**TURBOMECA  
MAKILA  
OVERHAUL MANUAL**

2. Table of visual and view-room checks

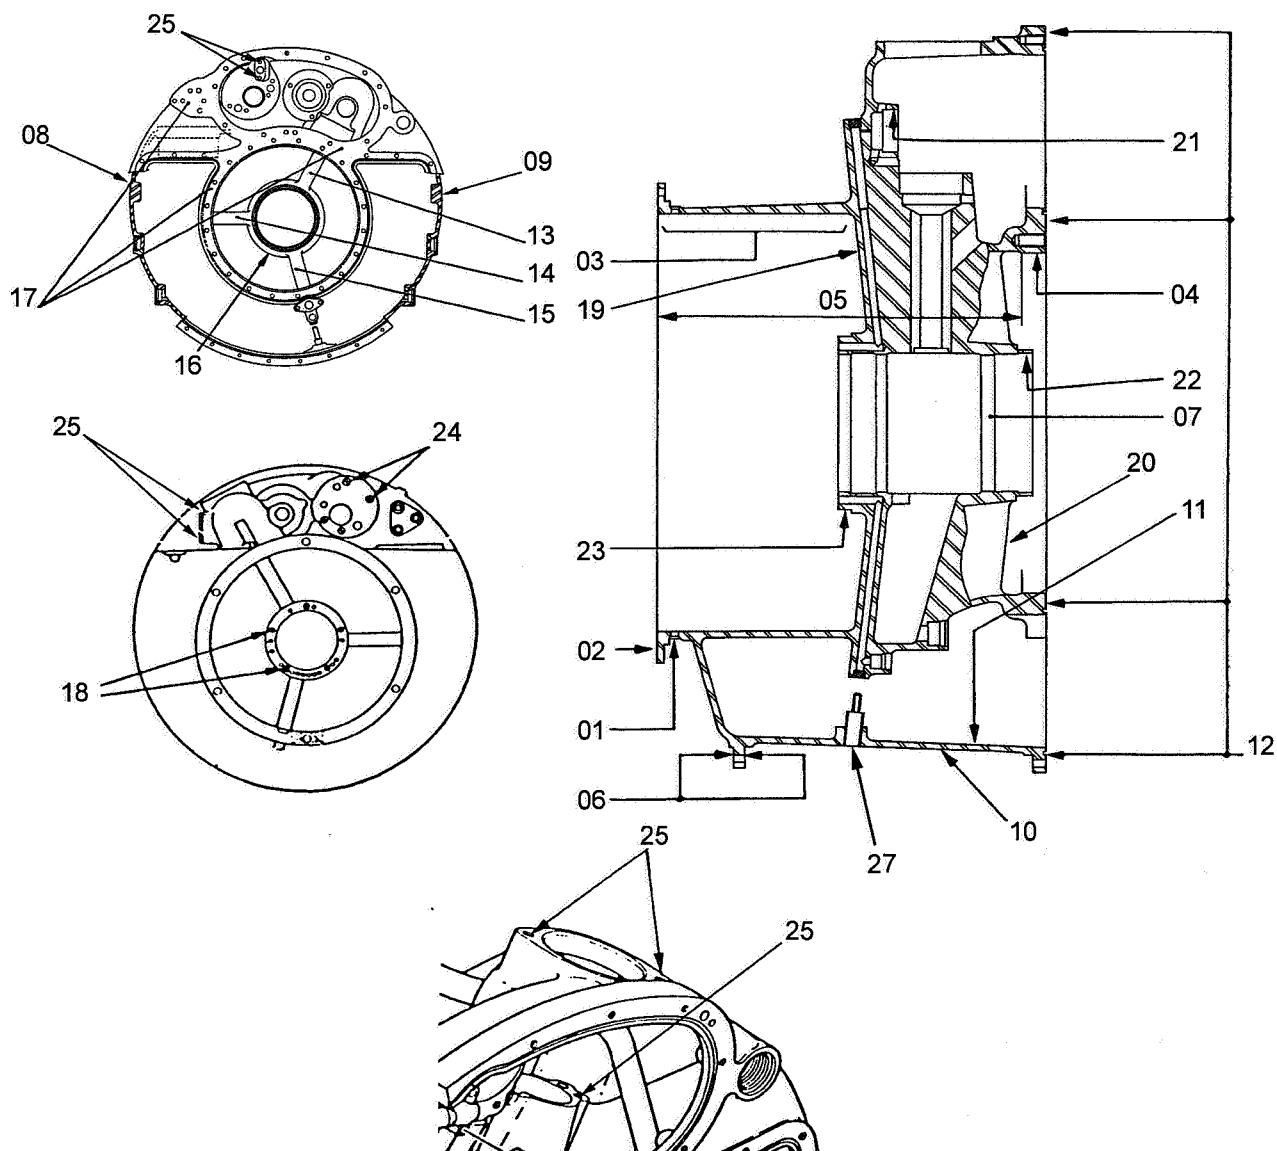
Figure 301 - Inspection of air intake casing pre-mod. TU82

A. AIR INTAKE CASING						ITEM: 0522	
REMARKS: "Magnesium" version (pre-mod. TU82)						FIGURE: 301	
HEALTH INSPECTION: CTB Task 70-30-53-230-801 (W2), Crack = Rejection							
LOCA	FINDINGS	CODE	CRITERIA		REP.	O/H	ACTION
01	Corrosion	083	Any value		x	x	SP-0522-04 SP-0522-03
	Dimension beyond maxi. Criteria	109	Diameter > 7 mm			x	SP-0522-07
02	Corrosion	083	Depth < 1 mm		x	x	SP-0522-04 SP-0522-03
			Depth > 1 mm		x	x	RP-0522-03 SP-0522-03
03	Corrosion	083	Depth ≤ 2 mm		x	x	SP-0522-04 SP-0522-03
04	Corrosion	083	Max. depth 1 mm, continuous over 90° of circumference		x		SP-0522-04 SP-0522-03
			Max. depth 3 mm, continuous over 120° of circumference		x	x	RP-0522-03 SP-0522-03
05	Corrosion	083	Depth ≤ 2 mm		x	x	SP-0522-04 SP-0522-03
06	Corrosion	083	Maximum total depth of both faces = ½ flange		x	x	SP-0522-04 SP-0522-03
07	Contact wear	184	Diameter within tolerances		x	x	Chromating with pad CTB Task 70-41-76-330)

07	Dimension beyond maxi. Criteria	109	Diameter > 91.022 mm		x	x	RP-0522-01

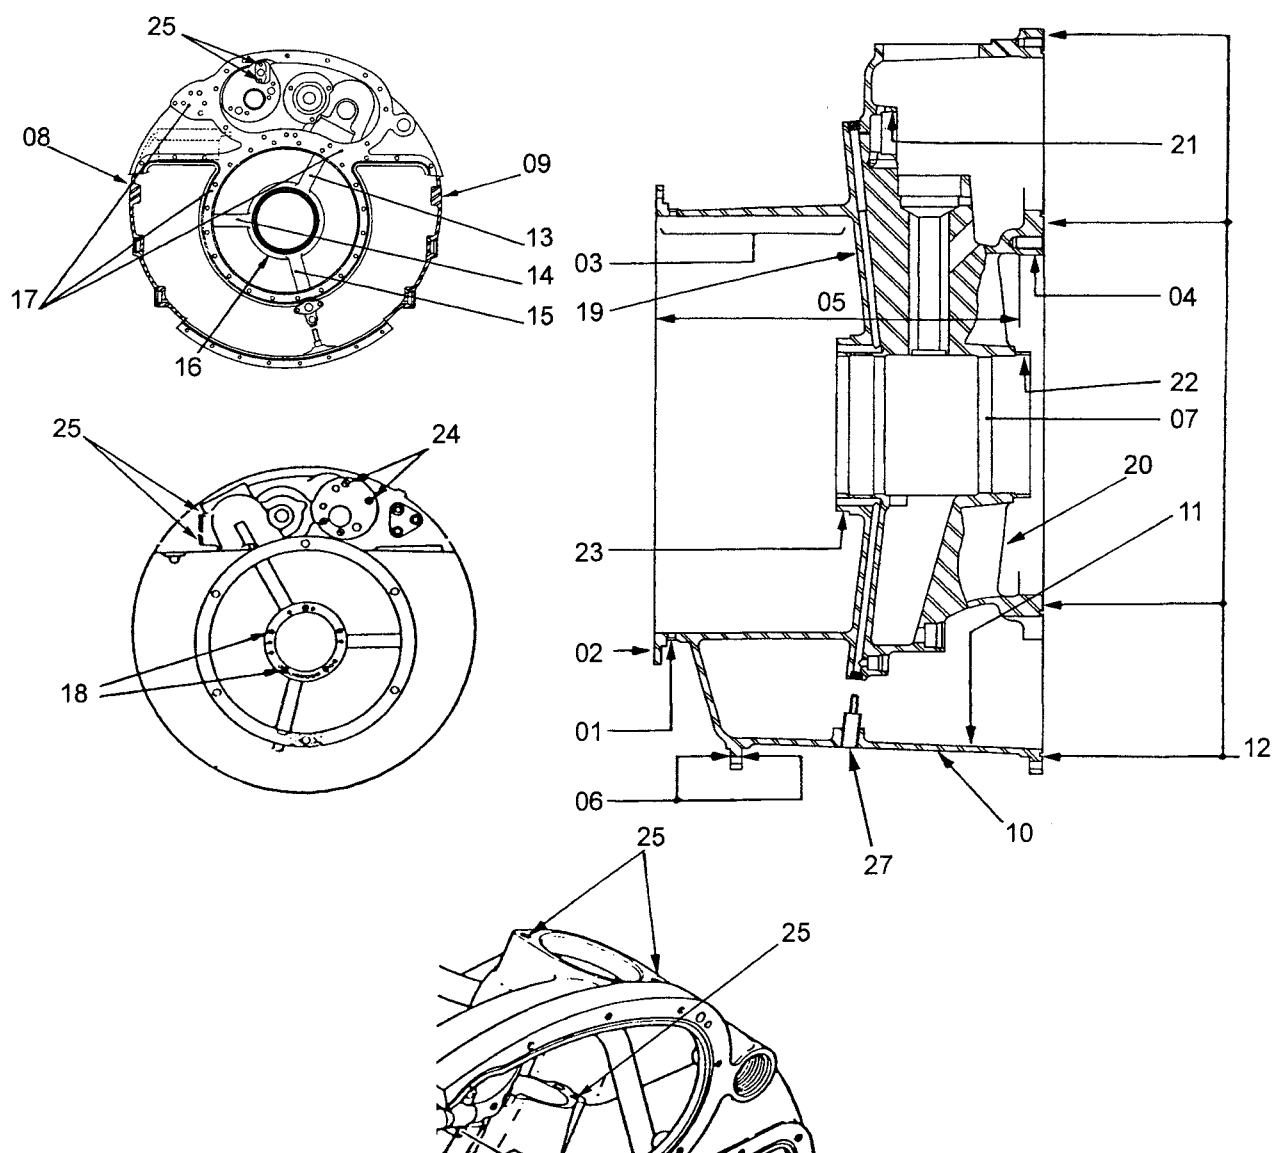
Figure 301 - Inspection of air intake casing pre-mod. TU82

A. AIR INTAKE CASING (continued)						ITEM: 0522	
REMARKS: "Magnesium" version (pre-mod. TU82)						FIGURE: 301	
HEALTH INSPECTION: CTB Task 70-30-53-230-801 (W2), Crack = Rejection							
LOCA	FINDINGS	CODE	CRITERIA		REP.	O/H	ACTION
08	Paint flaking	509	With no traces of corrosion		x	x	SP-0522-03
			With traces of corrosion		x	x	SP-0522-04 + SP-0522-03
09	Paint flaking	509	With no traces of corrosion		x	x	SP-0522-03
			With traces of corrosion		x	x	SP-0522-04 + SP-0522-03
10	Paint flaking	509	With no traces of corrosion		x	x	SP-0522-03
			With traces of corrosion		x	x	SP-0522-04 + SP-0522-03
11	Corrosion	083	Max. depth: ½ thickness		x	x	SP-0522-04 + SP-0522-03
	Paint flaking	509	With no traces of corrosion		x	x	SP-0522-03
			With traces of corrosion		x	x	SP-0522-04 + SP-0522-03
12	Corrosion	083	Any value		x	x	Smoothing/trimming + chromate treatment with pad (CTB Task 70-41-76-330)
13	Corrosion	083	Max. depth = 2 mm		x	x	SP-0522-04 + SP-0522-03

14	Corrosion	083	Max depth = 2 mm		x	x	SP-0522-04 + SP-0522-03
15	Corrosion	083	Max depth = 2 mm		x	x	SP-0522-04 + SP-0522-03

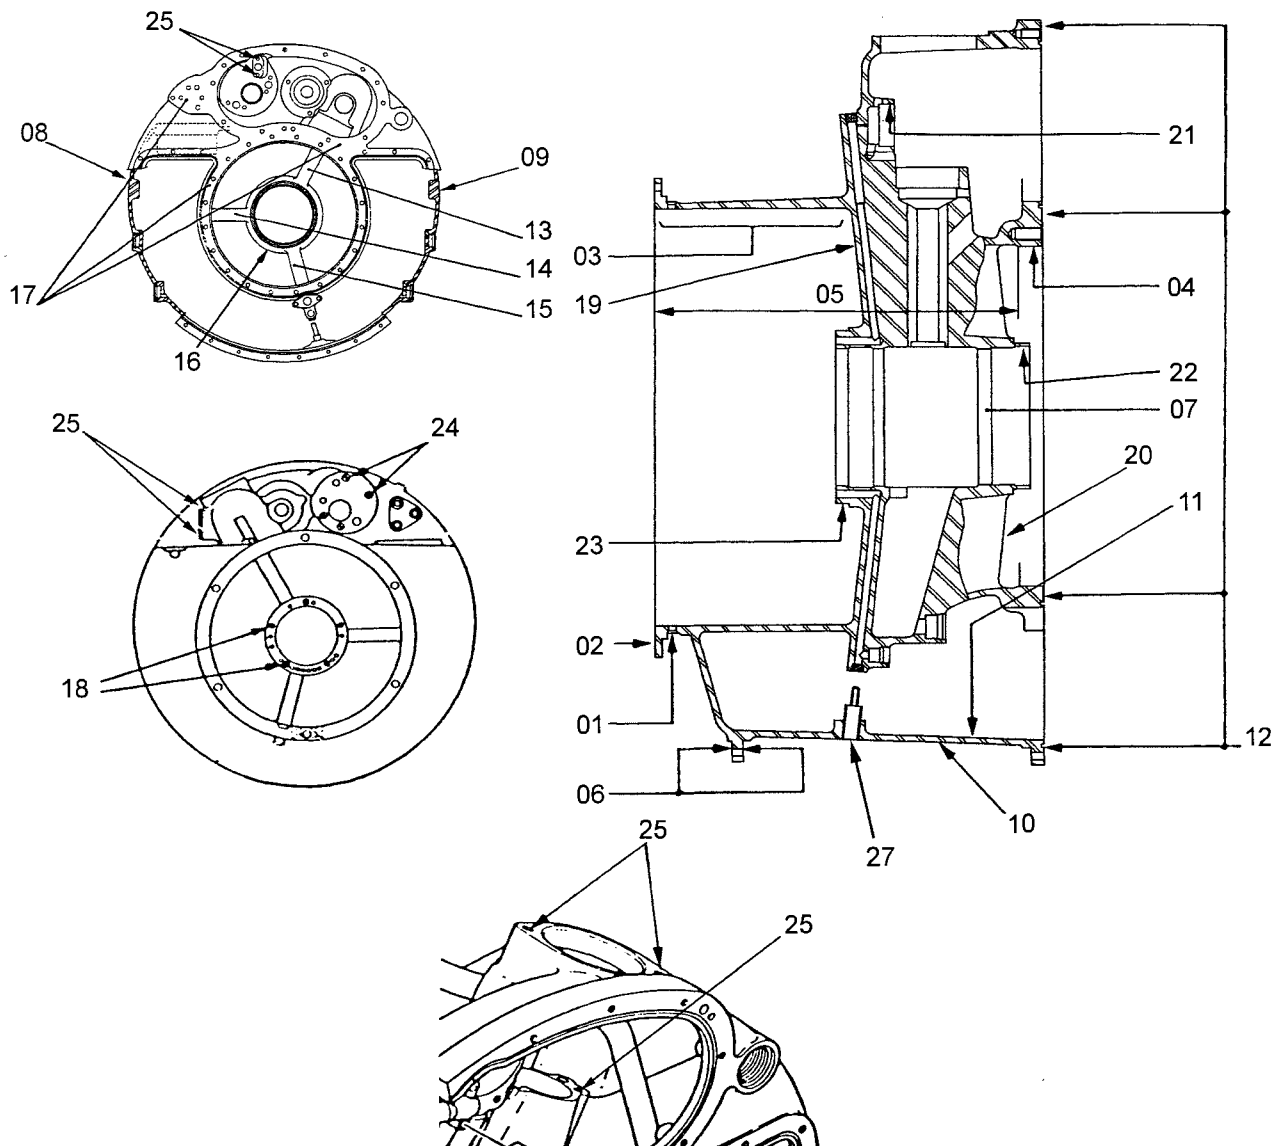
Figure 301 - Inspection of air intake casing pre-mod. TU82

A. AIR INTAKE CASING (Continued)						ITEM: 0522	
REMARKS: "Magnesium" version (pre-mod. TU82)						FIGURE: 301	
HEALTH INSPECTION: CTB Task 70-30-53-230-801 (W2), Crack = Rejection							
LOCA	FINDINGS	CODE	CRITERIA		REP.	O/H	ACTION
16	Corrosion	083	Max. depth = 2 mm		x	x	SP-0522-04 + SP-0522-03
17	Flaking	509	If sealing is uncertain		x	x	SP-0522-06
18	Stripping	516	If thread insert only		x	x	SP-0522-05
19	Corrosion	083	If casing damaged		x	x	RP-0522-04
			Maximum depth = 2 mm		x	x	SP-0522-04 + SP-0522-03
20	Corrosion	083	Depth > 2 mm		x	x	Rejection
			Maximum depth = 2 mm		x	x	SP-0522-04 + SP-0522-03
21	Dimension beyond maxi. Criteria	109	Depth > 2 mm		x	x	Rejection
			Any value (theoretical $\varnothing 28^{+0.002}_{-0.011}$ )		x	x	RP-0522-07
<u>NOTE:</u> If the casing is not modified according to CA 38066, it is possible to modify it by applying SI 38066 - Refer to page 1400 of this chapter.

22	Corrosion	083	Any extent		x	x	RP-0522-09
23	Corrosion	083	Any extent		x	x	RP-0522-08
24	Stripping	516	If thread insert only is damaged		x	x	SP-0522-05
25	Stripping	516	If casing damaged		x	x	RP-0522-10
			If thread insert only is damaged		x	x	SP-0522-05
			If casing damaged		x	x	RP-0522-04

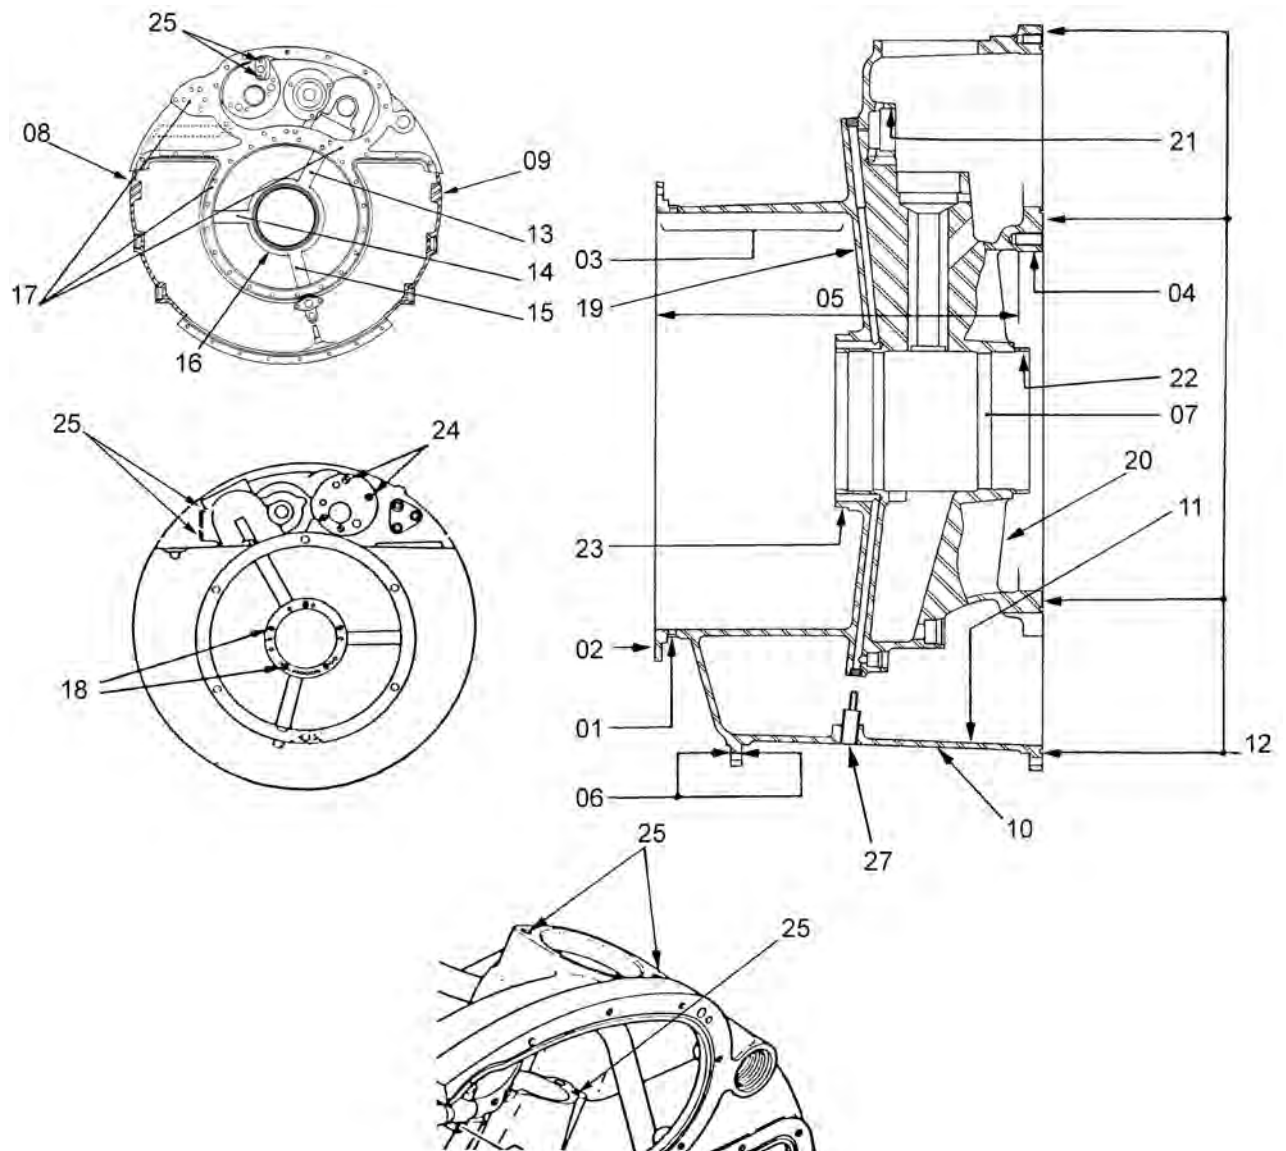
Figure 301 - Inspection of air intake casing pre-mod. TU82

A. AIR INTAKE CASING (Continued)						ITEM: 0522	
REMARKS: "Magnesium" version (pre-mod. TU82)						FIGURE: 301	
HEALTH INSPECTION: CTB Task 70-30-53-230-801 (W2), Crack = Rejection							
LOCA	FINDINGS	CODE	CRITERIA		REP.	O/H	ACTION
26	- Not used -						
27	Separated	736	Any value		x	x	RP-0522-15
	Breakage	052	Any value		x	x	RP-0522-15

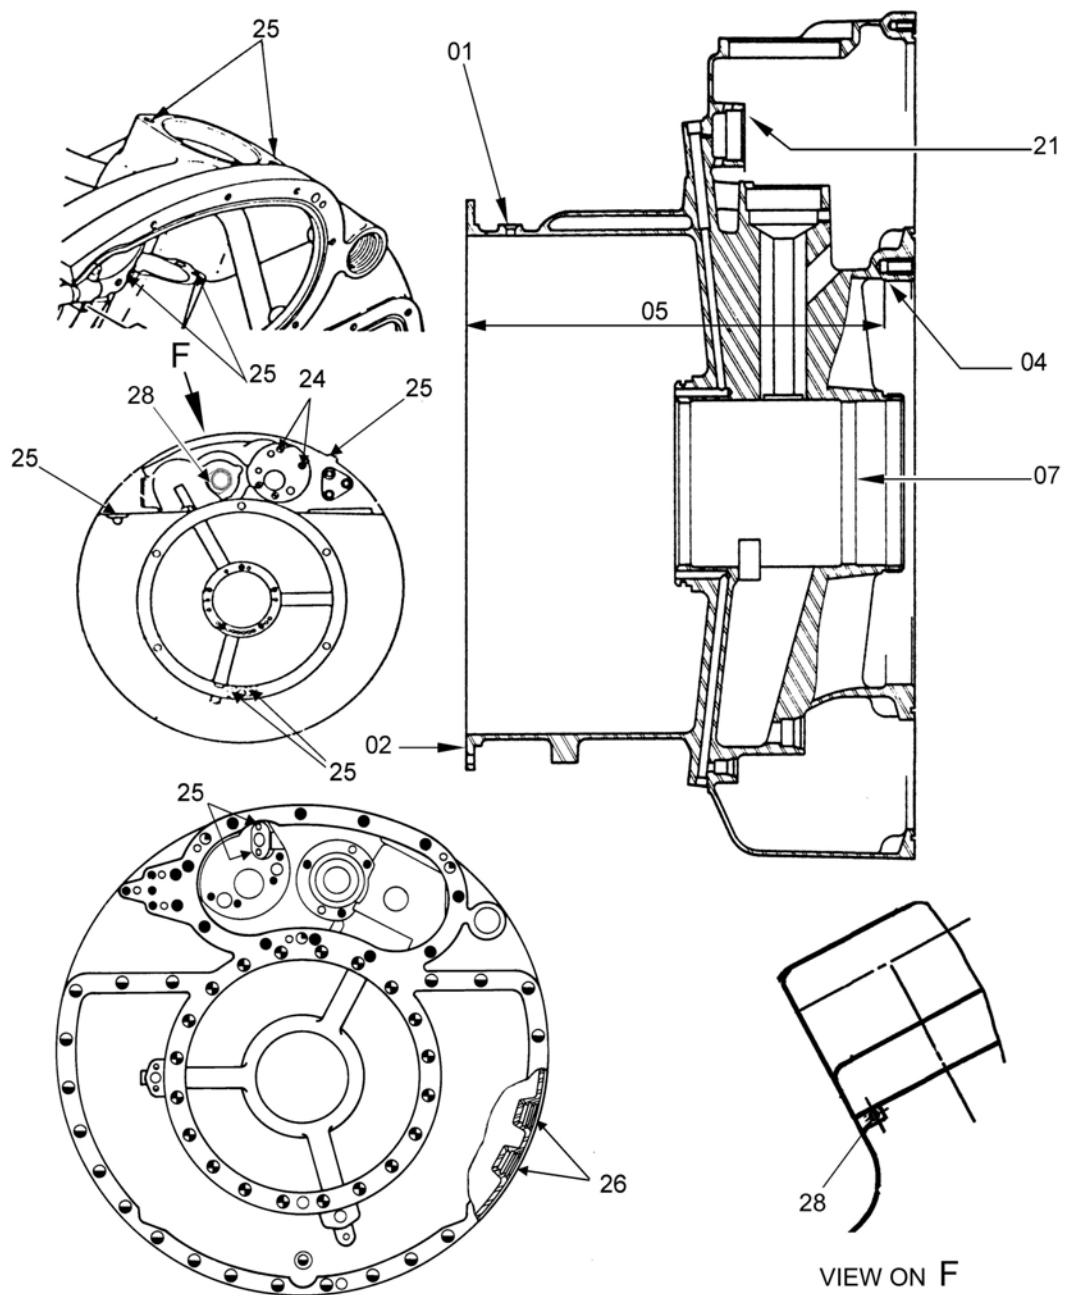
Figure 301F - Inspection of air intake casing TU82

B. AIR INTAKE CASING						ITEM: A522	
REMARKS: "Aluminium" version TU82						FIGURE: 301F	
HEALTH INSPECTION: CTB Task 70-30-53-230-801 (W2), Crack = Rejection							
LOCA	FINDINGS	CODE	CRITERIA		REP.	O/H	ACTION
01	Dimension beyond maxi. Criteria	109	Diameter > 7 mm			x	SP-0522-07
02	Corrosion	083	Corrosion depth ≤ 0.2 mm		x	x	Acceptable after chemical conversion (Refer to CTB Task 70-41-56-330-801)
			If more than this limit		x	x	Quarantine
	Chafing	184	Depth ≤ 0.2 mm		x	x	SP-A522-01
			Depth > 0.2 mm		x	x	Quarantine
04	Perpendicularity	415	Air path continuity (air intake casing/counter-casing) ensured Air path continuity not ensured		x	x	Acceptable as such SI 41778 Refer to Chapter 72-01-20, page 1400
04	Corrosion	083	Any extent		x	x	SP-A522-14 + RP-A522-13
05	Peened	433	Max. depth 0.5 mm		x	x	SP-A522-01
07	Chafing	184	Diameter within tolerances		x	x	Chromic acid anodisation with a pad (CTB Task 70-41-56-330-801)

Diameter > 91.022 mm		x	x	RP-A522-12
21	Dimension beyond maxi. Criteria	109	Any extent		x	x	RP-A522-07
24	Stripping	516	If thread insert only is damaged		x	x	SP-0522-05
			If casing damaged		x	x	RP-0522-10
25	Stripping	516	If thread insert only is damaged		x	x	SP-0522-05
			If casing damaged		x	x	RP-0522-04
26	Flaking	510	Any extent		x	x	SP-A522-12

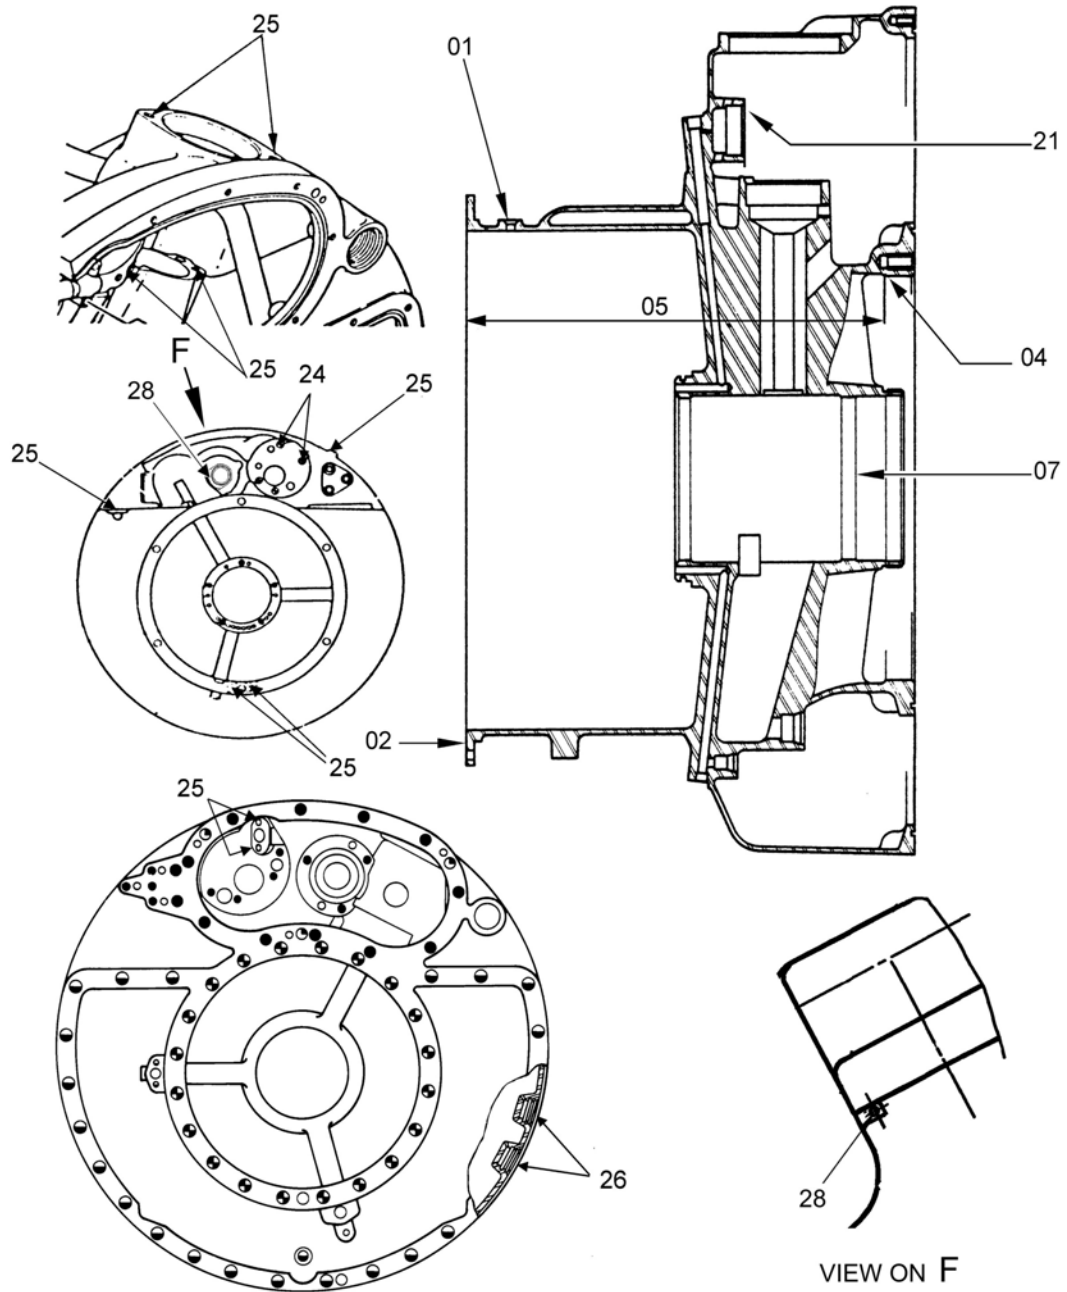
Figure 301F - Inspection of air intake casing TU82

B. AIR INTAKE CASING						ITEM: A522	
REMARKS: "Aluminium" version TU82						FIGURE: 301F	
HEALTH INSPECTION: CTB Task 70-30-53-230-801 (W2), Crack = Rejection							
LOCA	FINDINGS	CODE	CRITERIA		REP.	O/H	ACTION
28	Stripped	516	However stripped		x	x	Drill a through hole Ø1.2 mm adjacent to the existing hole and obey a min. gauze thickness of 1 mm (Refer to Figure 301F) + chemical conversion (Refer to CTB Task 70-41-56-330-801)

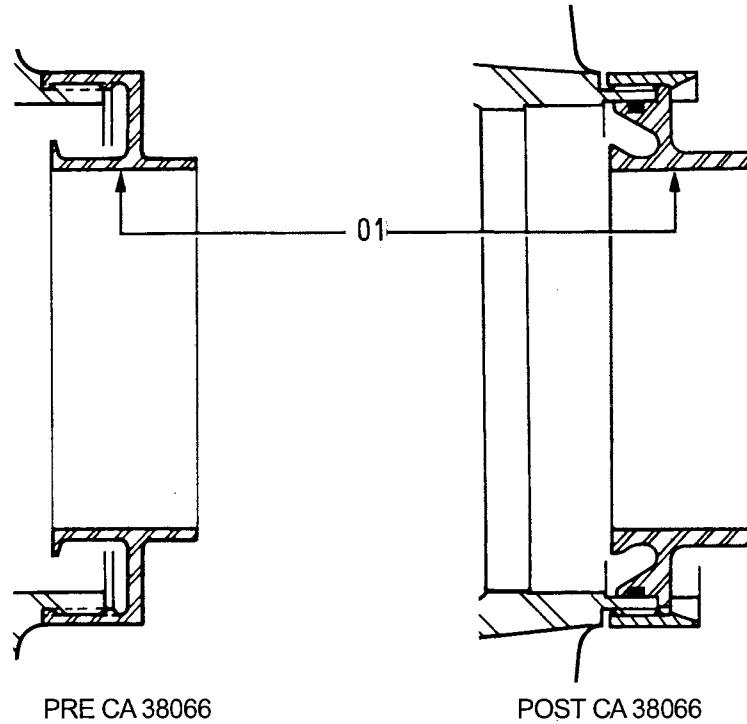
Figure 302 - Inspection of axial compressor front labyrinth ring

<b>C. AXIAL COMPRESSOR FRONT LABYRINTH RING</b>						<b>ITEM: B522</b>	
<b>REMARKS:</b>						<b>FIGURE: 302</b>	
<b>HEALTH INSPECTION:</b> CTB Task 70-30-53-230-801 (W2), Crack = Rejection							
LOCA	FINDINGS	CODE	CRITERIA		REP.	O/H	ACTION
01	Rub	471	Depth $\leq$ 0.1 mm Depth $>$ 0.1 mm Any value		x  x	x	Acceptable  Rejection  Rejection: systematically apply S.I. 38066

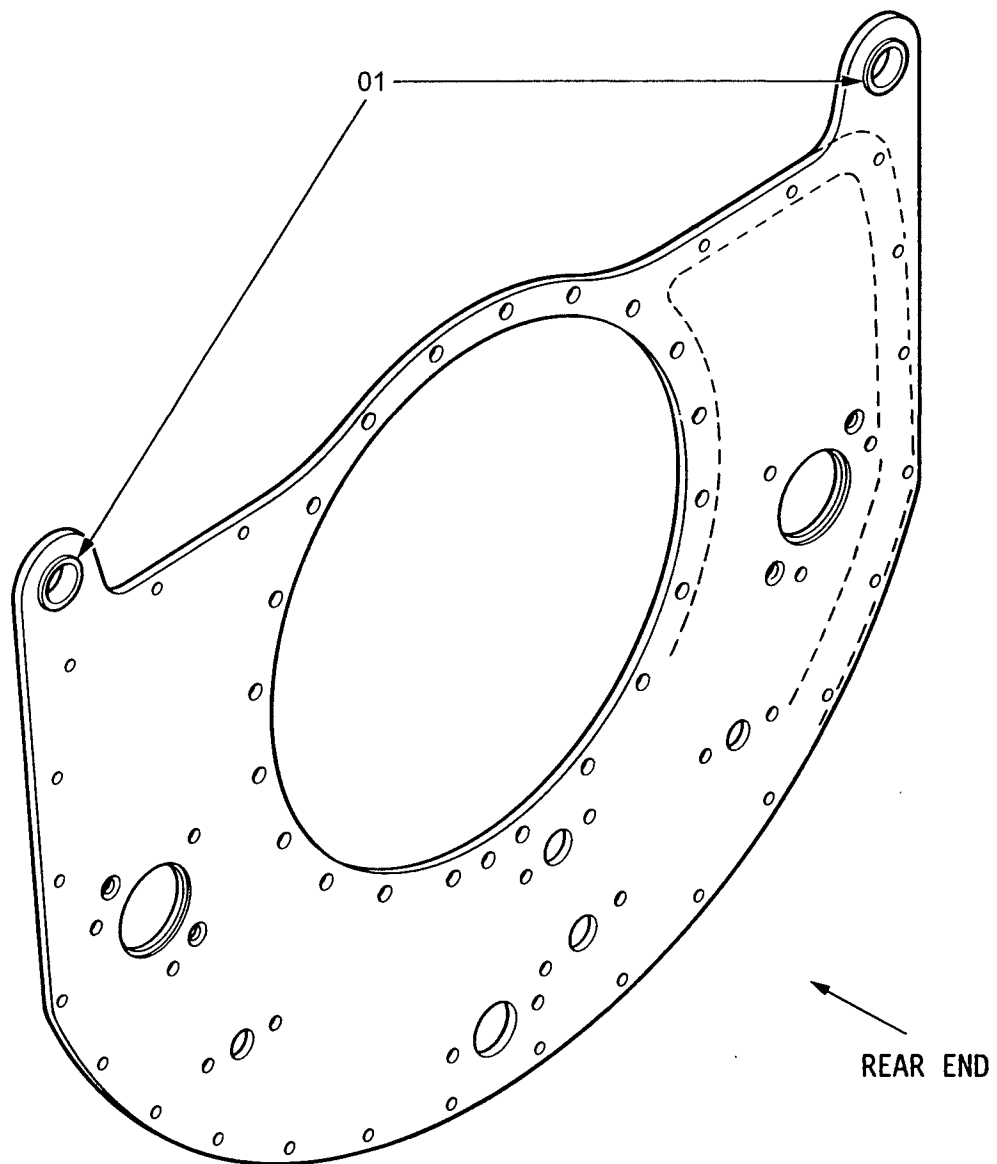
Figure 303 - Inspection of closing plate

D. CLOSING PLATE						ITEM: 0675	
REMARKS:						FIGURE: 303	
HEALTH INSPECTION: CTB Task 70-30-53-230-801 - Crack = Rejection							
LOCA	FINDINGS	CODE	CRITERIA		REP.	O/H	ACTION
01	Distorted (folding)	116	Plate not removed: max. fold angle = 15°		x		Acceptable
			Plate removed		x		SP-0675-01
			Any value			x	SP-0675-01
