Part Summary Data Sheet

Aisin AW TR-60SN

PART NUMBERS 25741-01K, F-25741-TL

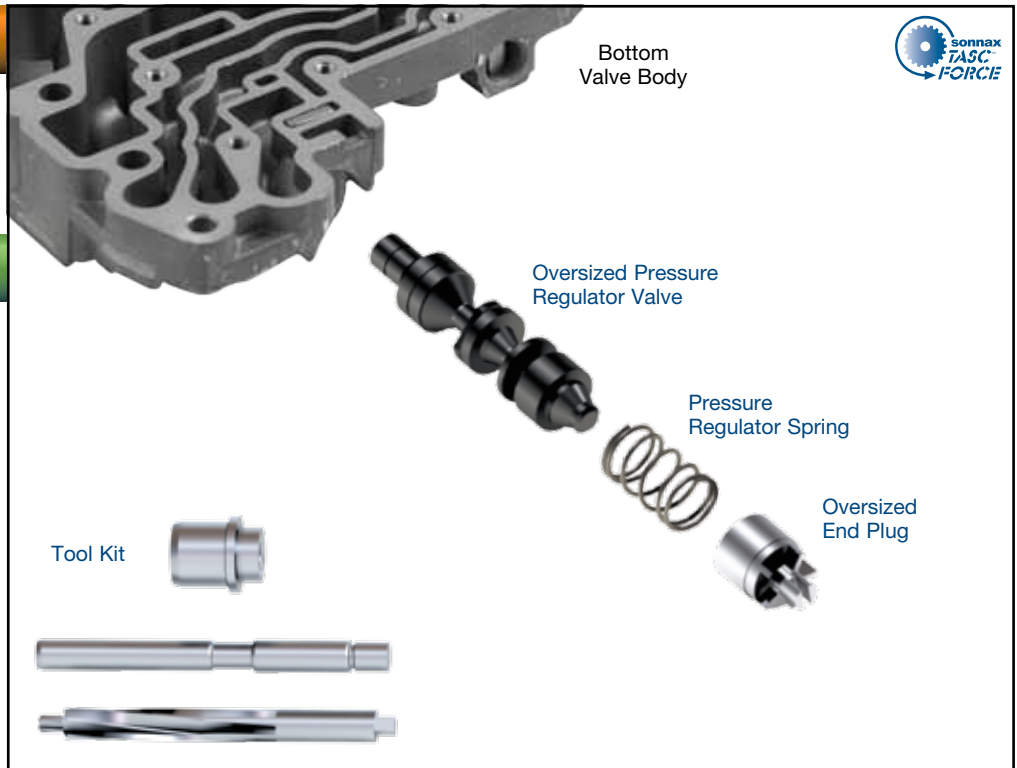
Aisin AW TR-60SN transmissions may exhibit multiple line pressure-related problems due to excessive wear in the main pressure regulator bore. Wear at the inner bore results in excess pressure and reduced cooler/converter flow. Wear at the plug end allows oil loss resulting in poor line rise and burnt clutches. Installing the Sonnax oversized pressure regulator valve and end plug kit **25741-01K** corrects pressure loss problems and restores proper pressure regulation. The oversized valve and calibrated spring match OE valve response, and the multi-position end plug allows you to match the original factory setting.

Refurbish the bore and install Sonnax oversized pressure regulator valve and end plug kit to eliminate poor line rise as well as excess pressure and overheating caused by valve and bore wear.

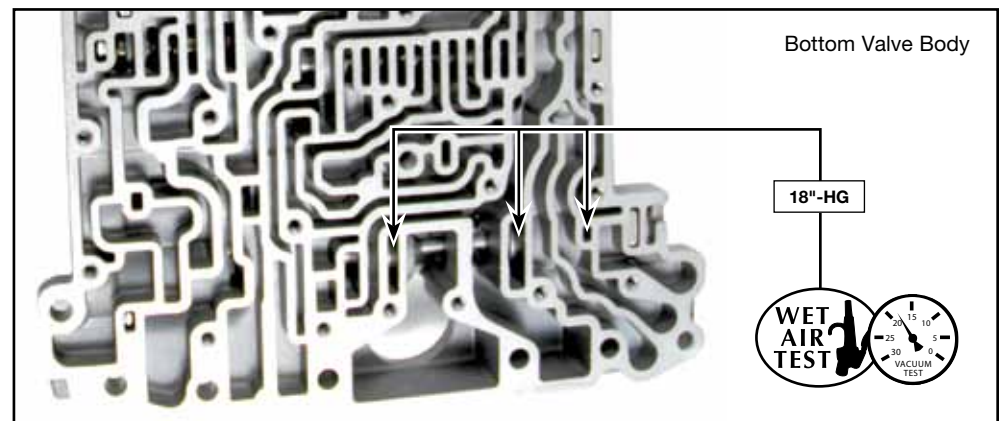
A vacuum test at indicated ports fails to yield 18 in.-hg or greater, or if visual wear is detected.
