Rear Planet Endplay Shim

12780-Z

Sonnax Part Summary

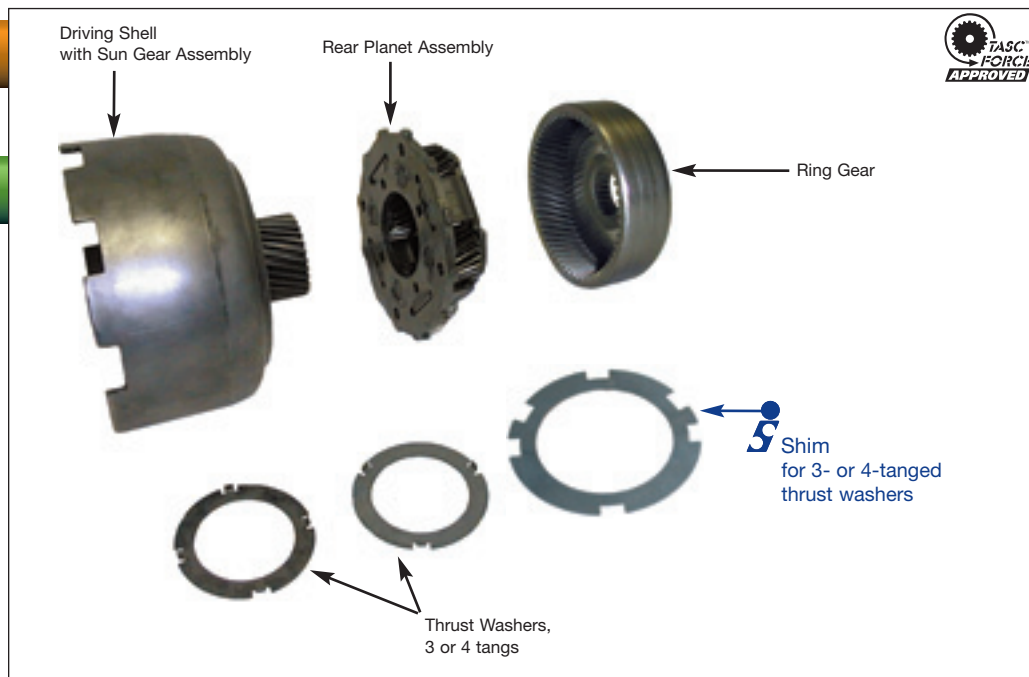
Excessive total transmission endplay

Worn gear, snap ring, and/or spline

It is often difficult to reduce the total transmission end play in some A904 or A500 transmissions. Excessive total and/or rear unit endplay is often the result of gear, snap ring and/or spline wear. Rear unit endplay is often difficult to reduce with available selective washers. When rear unit endplay is loose, the total unit endplay measurement is also excessive. Sonnax offers a .010" shim, 12780-Z, which is installed between the #9 thrust washer and the rear planetary.

This Sonnax shim allows for adjustment of the total and rear unit endplay. Works with both 3- and 4-tanged thrust washers.

- Adding a shim or shims between the #9 thrust washer and the rear planetary reduces rear unit endplay as well as total assembled transmission endplay.
- The Sonnax shim will fit either the 3- or 4-tang OEM thrust washer design.
