Transfer Case Pump Plate Kit

100246-02K

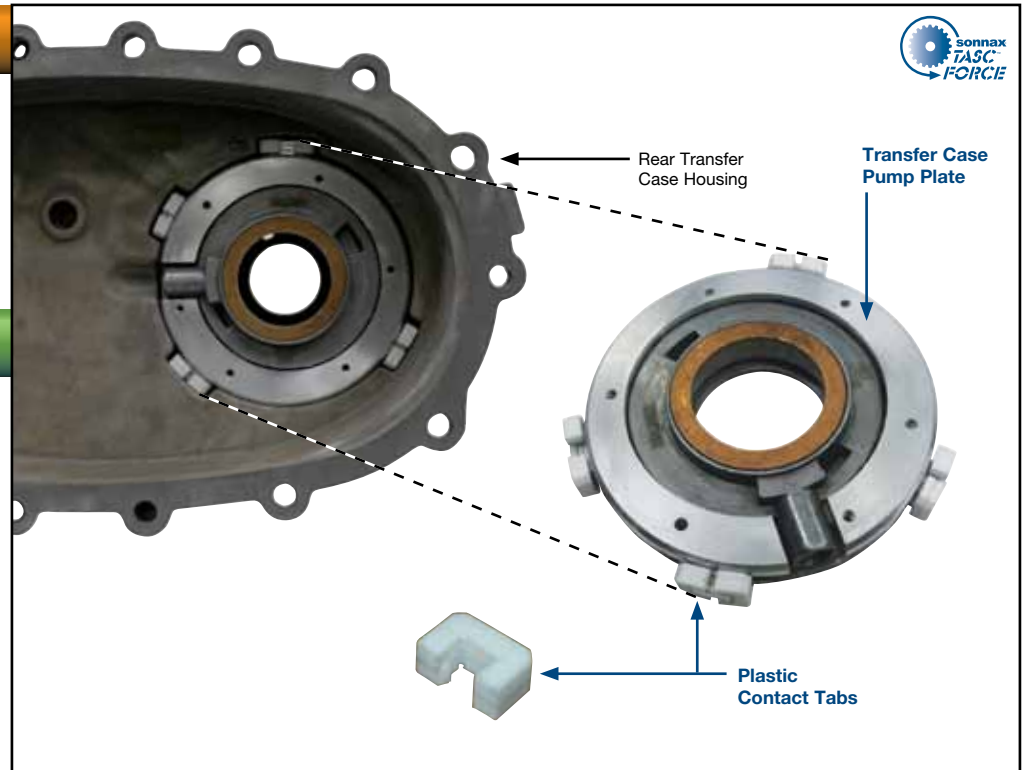
Pin-hole oil leaks in rear transfer case housing

- Wear of rear housing from pump tab contact
- Damaged transfer cases must be scrapped

Constant movement of the transfer case pump locating tabs in the rear half of the magnesium housing creates wear due to the abrasiveness of the aluminum and the concentrated contact of the pump tabs against the magnesium housing.

Accelerated wear of magnesium transfer case housings has been documented any time internal parts move against the magnesium. This is especially evident in New Venture/New Process 136, 149, 236, 246, 261 and 263 transfer cases. The sharp edges of the aluminum pump locating tabs cut through the soft magnesium, or other times the sharp edges of the OE U-shaped insert wear a larger area above the pump tabs. A small amount of movement of the pump is necessary to keep the pump centered on the output shaft. Experience has shown that any metal in contact with the magnesium causes rapid fretting wear of the soft magnesium, resulting in pin hole leaks.

Eliminate all aluminum and steel contact of the OE pump parts with the soft magnesium housing by using the easily installed Sonnax pump plate with abrasion-resistant plastic contact tabs.

Sonnax transfer case pump plate **100246-02K** eliminates all metal-to-magnesium contact of the pump by replacing the OE pump tabs with low-friction plastic inserts, and eliminating the U-shaped steel insert. The new tab design relocates contact away from the original wear points, so any weld or patches on worn housings will not be disturbed.
