Line Pressure Plug & Sleeve Kits

Sonnax Part Summary

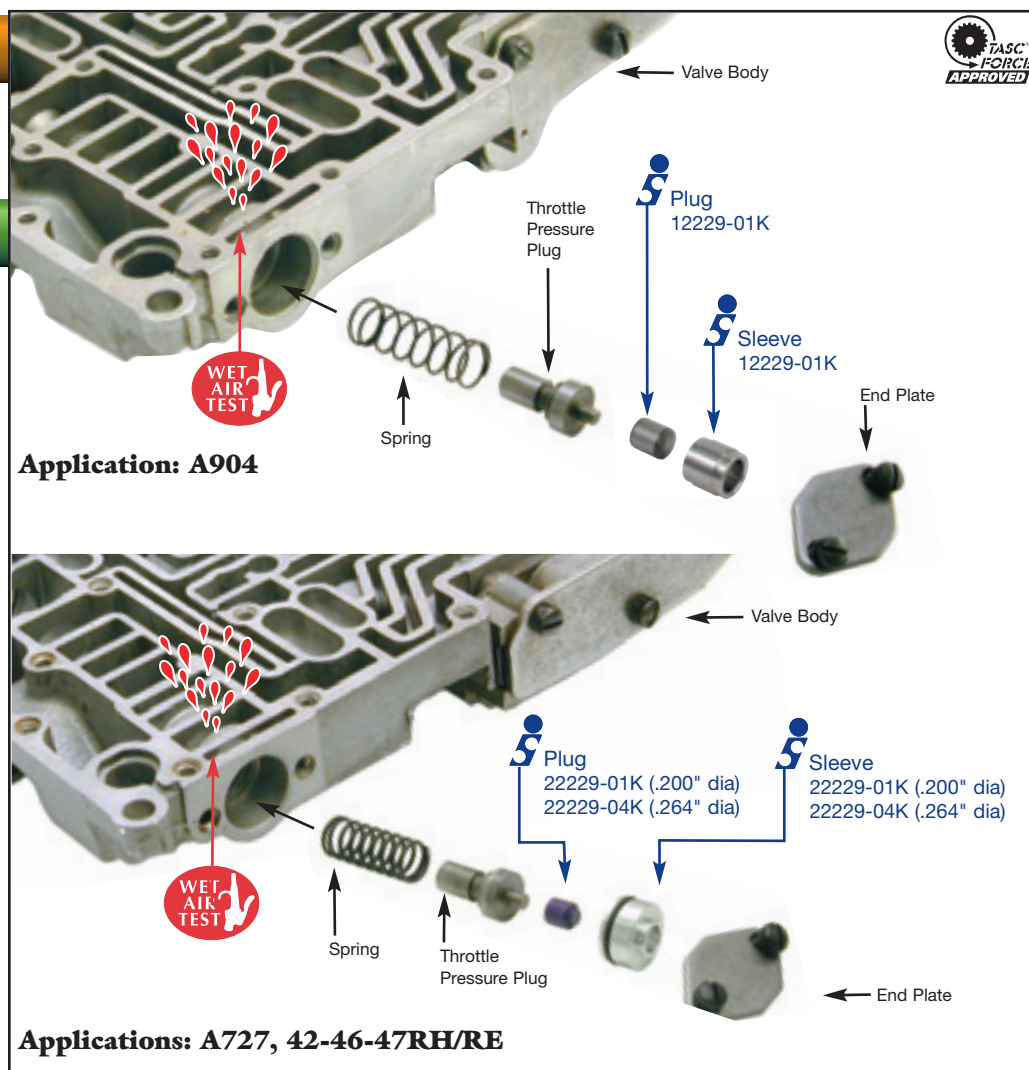
Slippage in reverse

• Poor cooler charge at idle • Poor line control • Poor forward and reverse engagement

Excessive wear at the regulator valve pressure sleeve and low reverse boost pressure.

Vehicles with A904, A727 and 42-46-47RH/RE transmissions may have problems with slippage in reverse, poor cooler charge at idle, and high or low line control. These complaints are often due to excessive wear at the line pressure plug and sleeve. When this sleeve and plug wears, leakage past the plug prevents the pressure regulator valve from properly controlling line pressure.

These upgraded sleeve and plug kits restore the hydraulic integrity of the circuit.

- Sleeve and plug allows pressure regulator valve to properly control line pressure.
- For A727, 42-46-47RH/RE units, the **22229-01K** plug diameter of .200" matches the later OE design to increase reverse boost, while o-ring prevents line pressure cross leaks.
- For A727 and 42-46-47RH/RE units, the earlier standard OEM .264" diameter plug is now available in **22229-04K**.
