Don't Let Run-out Make Problems for Your 4L60-E

By Gregg Nader

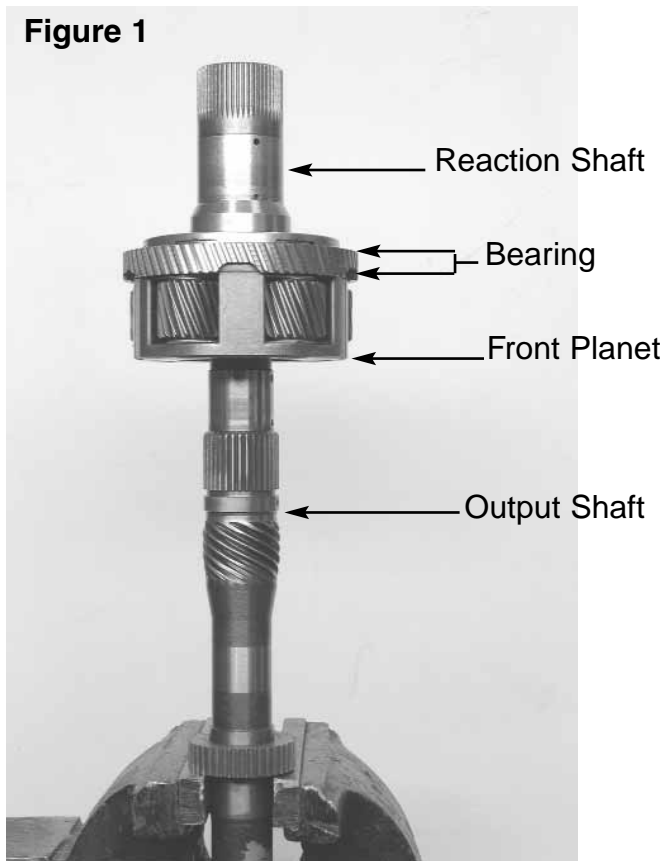
Clamp the output shaft in a vise and stack the parts as shown in Figure 1.

Note: Some output shaft splines may allow the front planet to slide down past the splines, so you may have to look for an output shaft that holds the planet in place as shown in Figure 1.

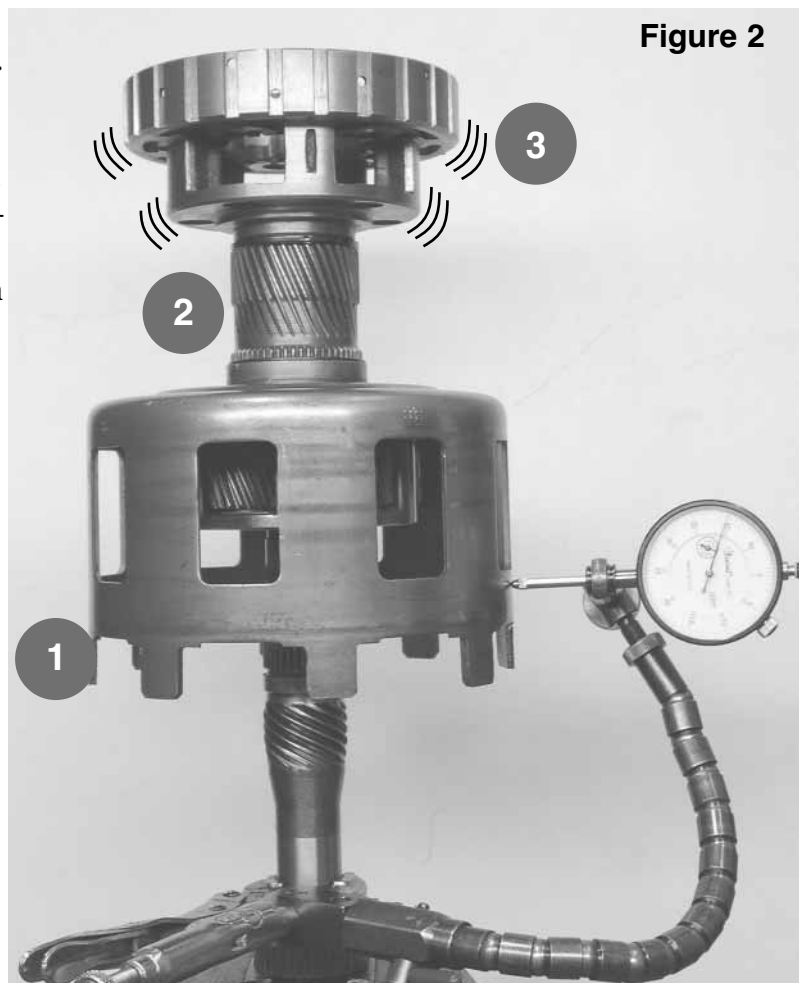
Figure 2

To check your reaction shell and rear sun gear, place them over the other parts and top off with the rear planet bearing and carrier as shown in Figure 2. The reaction shell and sun gear are now sandwiched between bearings, and the shell should spin freely to allow run-out checks and inspection of the sun gear.

1. Check run-out of the shell. Most have about .010" run-out when checked here. On others there has been as much as .050" of wobble! This will contribute to reaction shell breakage, spline wear, and could contribute the rare 2nd gear shudder these have been known to have.
2. Check the gear tooth contact pattern on used sun gears. A pattern that moves around indicates a poorly manufactured gear.
3. As the shell/sun gear spins, watch the planet sitting on top. A wobbling sun gear causes the planet to rock back and forth. This can be due to the sun gear bushing being out of position, or a poorly manufactured sun gear.

When you see the run-out and wobbling some of these parts have, it is easy to connect them to the common failures of rear planet bearings and reaction shells that these units are known for.
