Part No. 12502-01

BUJE DE BOMBA CON MEDIDAS PRECISAS

SONNAX PART SUMMARY

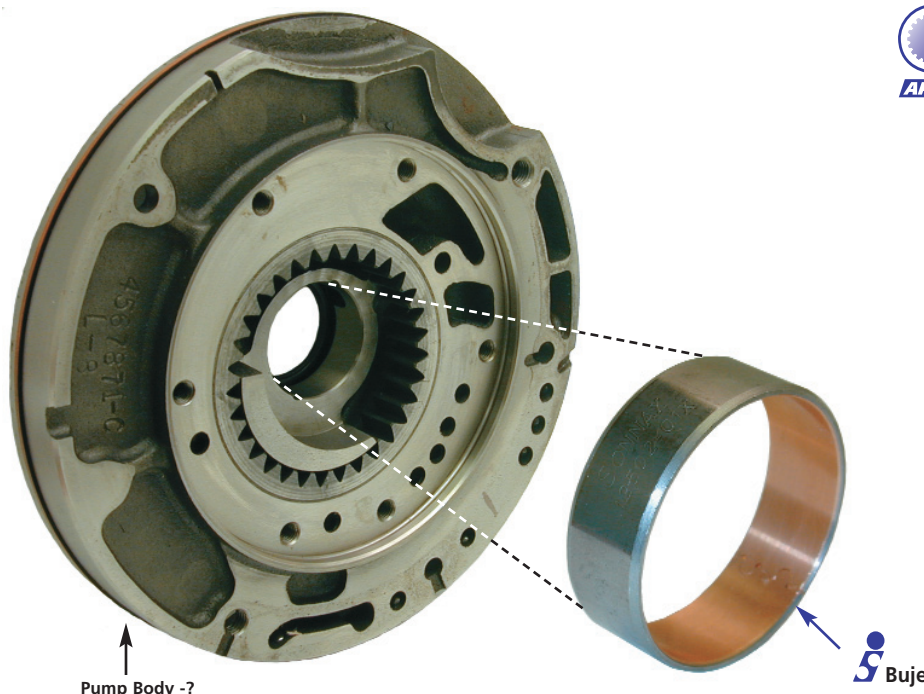
Fugas en sello de bomba, Códigos 35 y 38

Espacio excesivo entre el cuello y el buje que causa un volumen reducido de la bomba.

Excessive converter hub to front pump bushing clearance can result in code 38,35, TCC complaints and front seal leakage. The Sonnax pump bushing 12502-01 will restore the clearance necessary for proper operation.

Este buje con medidas precisas va a restaurar el espacio necesario para un funcionamiento correcto y también puede bajar la pérdida de aceite.

Remove the worn bushing from the pump housing using an appropriate bushing driver. Inspect the pump housing bore for any damage. Also inspect the torque converter hub for signs of wear. The hub diameter should be no less than 1.497". Press in the Sonnax replacement bushing, again using the correct size bushing driver. Stake the bushing in place at the two notch locations. Be careful not to raise the surface of the I.D. of the bushing.

Check converter hub to pump bushing clearance after installation. Ideally, clearance should be .003" - .005". Do not use the Sonnax bushing if the clearance is .002" or less.
