3-4 Overlap Valve Kit

68942-31K

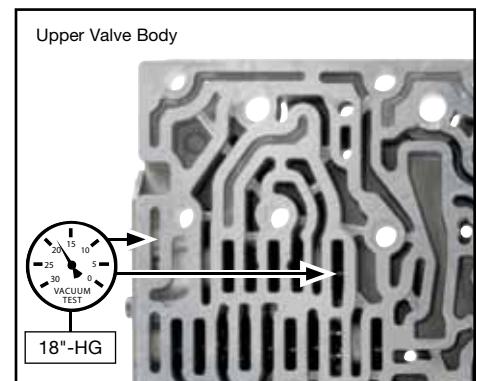
Wear at the overlap valve bore prevents proper exhaust of the disengaging clutch pressure, altering the precise timing required in the clutch-to-clutch shift transition.

A vacuum test at either port indicated fails to hold 18" of vacuum or higher or if visual wear is detected at the inboard overlap valve bores.

The improved Sonnax overlap valve kit restores hydraulic sealing integrity and valve timing when installed in a refurbished bore.
