Torque Fuse Troubleshooting

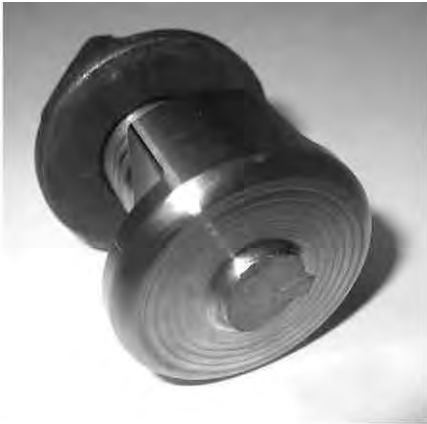
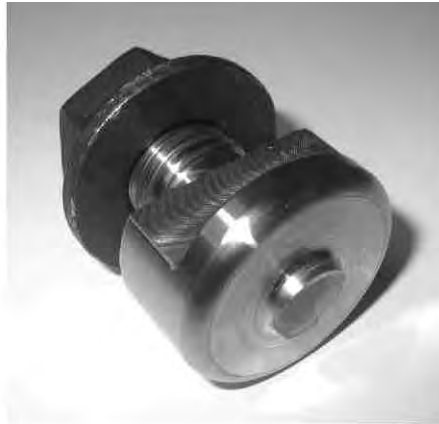
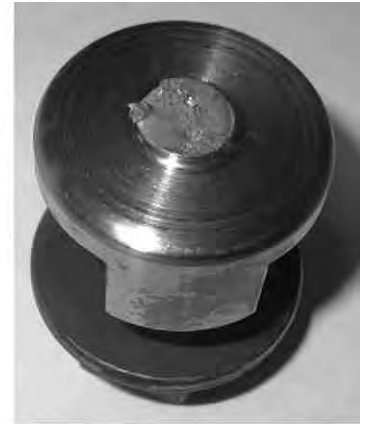
(A) Normal Shear Pattern

(A) Shows a normal shear pattern.

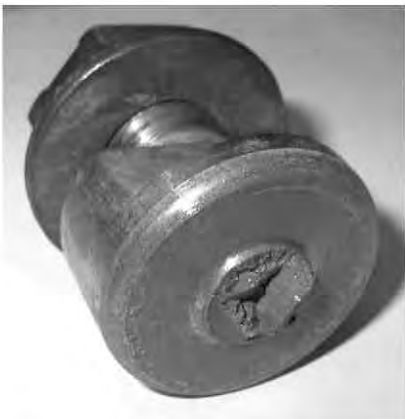
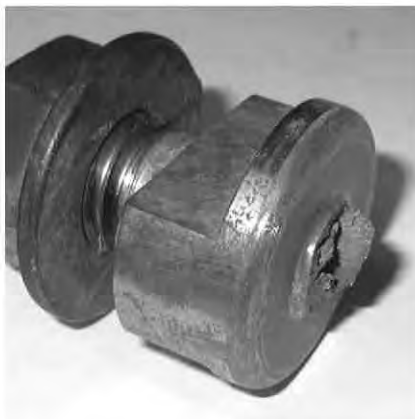
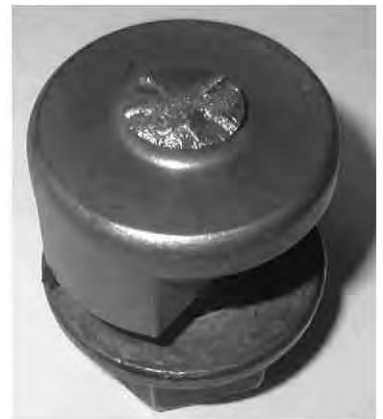
(B) Vibration Shear Pattern

(B) Shows what occurs when drive shaft has a vibration caused by:

1. Improper installation of Power Train Saver
(See Installation Instructions Page 4 in Parts Catalogue)
2. Torque Fuses not properly torqued down
(Torque Fuses must be torqued down to 220 Ft/Lbs)
