Go with the *flow*

What 740/1740 codes can tell you

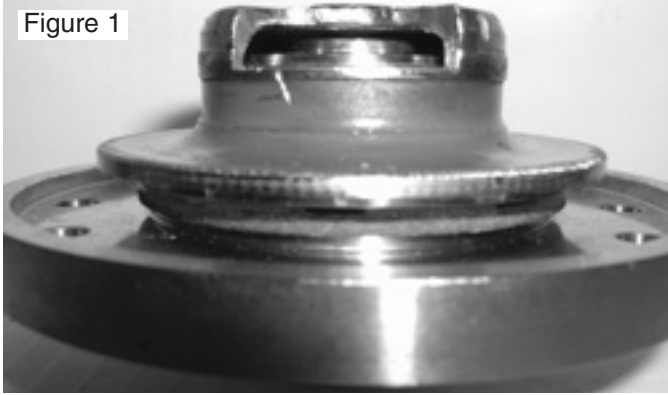
Figure 1

When the input (turbine) shaft is in its proper position in relation to the inside of the pilot (cover), it will look like the cut-away in Figure 1. The input shaft is about

.125" away from the cover when the converter is installed to its proper depth. The proper way to check converter-to-flexplate clearance is to push the converter back until the hub bottoms in the pump, then measure the distance between the flexplate and the converter pad. This measurement needs to be a minimum of .125", but no more than .250". The minimum of .125" is important to allow for a certain amount of converter expansion (ballooning), and to allow for a certain amount of movement by the flexplate. If the flexplate is bent, it could allow the converter to move rearward and restrict the flow of oil between the input shaft and cover. The example shown in Figure 2 was close enough to cause a 740 code.

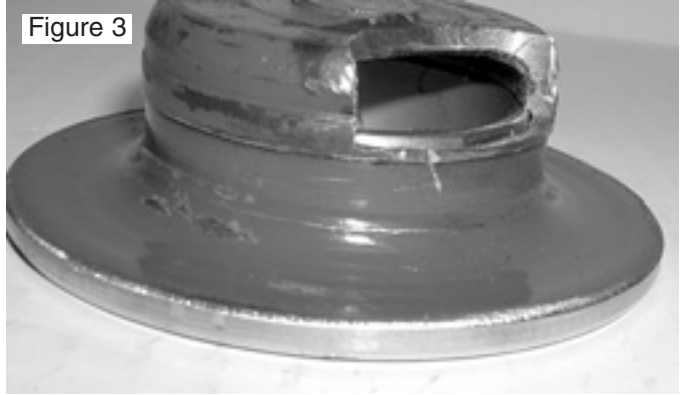
about .028" below the thrust area for the turbine hub. The cut-away in Figure 3 shows a bushing that was

installed .080" (twice the thickness of a dime) below flush. You are viewing the bushing from the bottom side so you can see that flow was completely restricted. This, too, caused a 740 code.

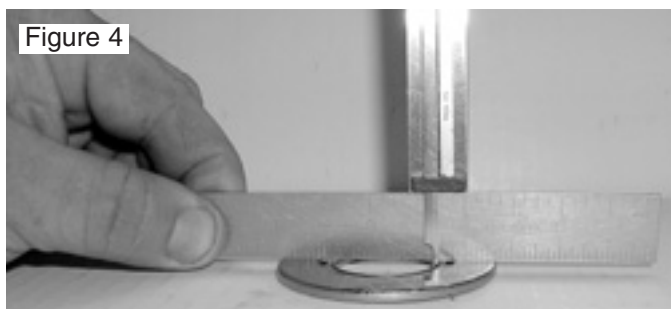
Figure 4

The input shaft of the 604 has more clearance at the cover, but clearance would probably not be an issue anyway, because of the stronger flexplate. The turbine hub bushing on the 604 looks like a smaller version of the 518 bushing with one less groove on the outside. When the bushing is installed to its proper depth, it is flush to .020" above the thrust surface of the cover. This is well above the .012" flow relief step at the top of the bore. The machined angle at the bottom of the bore for clearance is greater than its sister angle on the 518 converter and more flow-friendly. Special attention should be paid to the position of the bushing. Since the inner race of the O.E. bearing is only .015" below the thrust surface of the outer race (see Figure 4), it may come into contact with the bushing if the bushing is up .020" above flush as shown in Figure 5. The

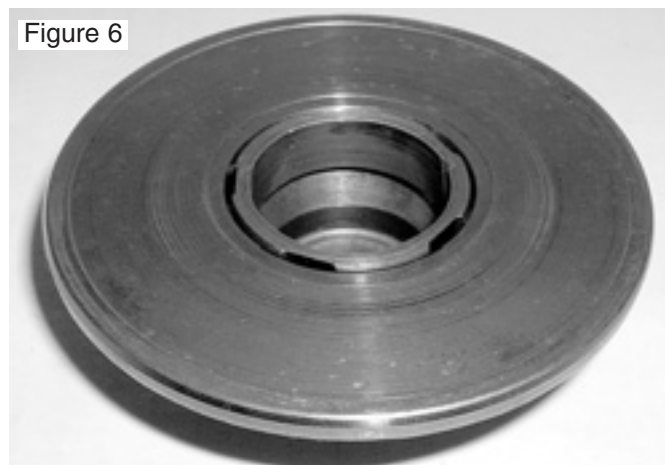
.005" of wear shown in Figure 6 is the result of that contact. This is a bad thing for two reasons: First, the

material from the bushing that was worn away by the bearing race has to pass through the bearing, and second, the pinpoint contact of the inner race of the bearing to the bushing may cause the race to flex and eventually fail. Either of these two concerns may help to explain the failure rate of the bearing.
