Replacement 1-2 Accumulator Piston & Pins

Sonnax Part Summary

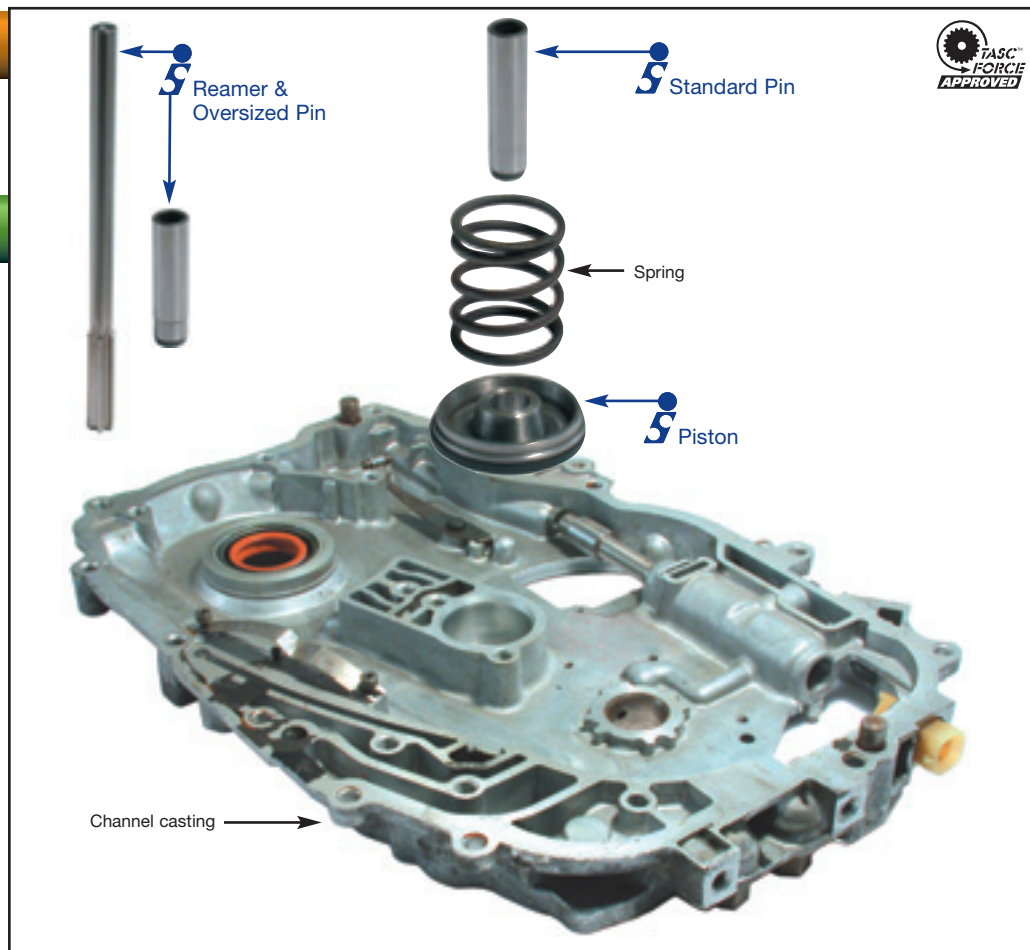
Burned forward clutches

• Delayed engagement • Poor shift quality • Wrong gear starts

The 1-2 accumulator piston wears at the pin bore due to contact with the steel pin.

This accumulator piston has a longer piston pin contact surface area to reduce wear on the piston and prevent cocking. Choose from the standard-sized replacement pin and piston, or optional reamer and oversized pins to salvage OE pistons.
