## Oversized Accumulator Pin & Reamer

### Sonnax Part Summary

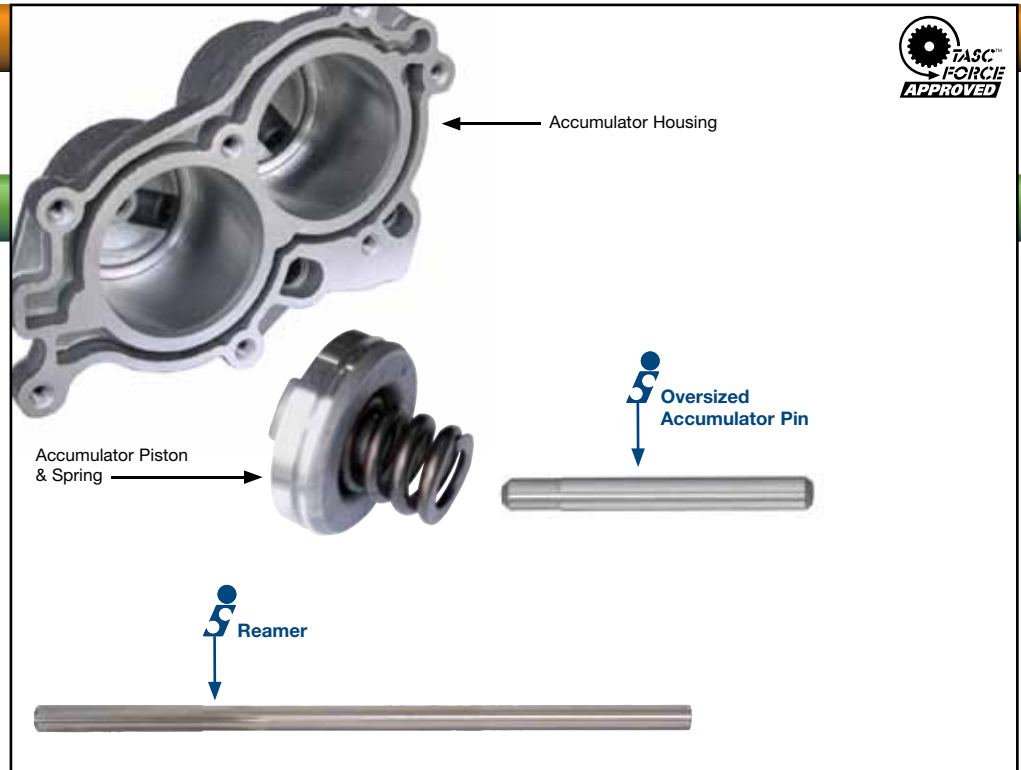
Worn 1-2 and 2-3 accumulator piston pin bore.

Inconsistent shifts, high shift adapt numbers and burned clutches in a 4T65-E can all be traced back to worn accumulator pistons. Pin bore wear allows clutch apply pressure to exhaust into accumulator circuits and decrease clutch apply pressure. Sonnax oversized pin kit **84754-51K** allows easy repairs of worn pistons and eliminates the need to purchase new pistons for different applications.

This oversized replacement accumulator pin restores the proper fit between the piston bore and pin, allowing re-use of the original aluminum piston.
