Boost Valve & Sleeve Kit

66942-01K

Sonnax Part Summary

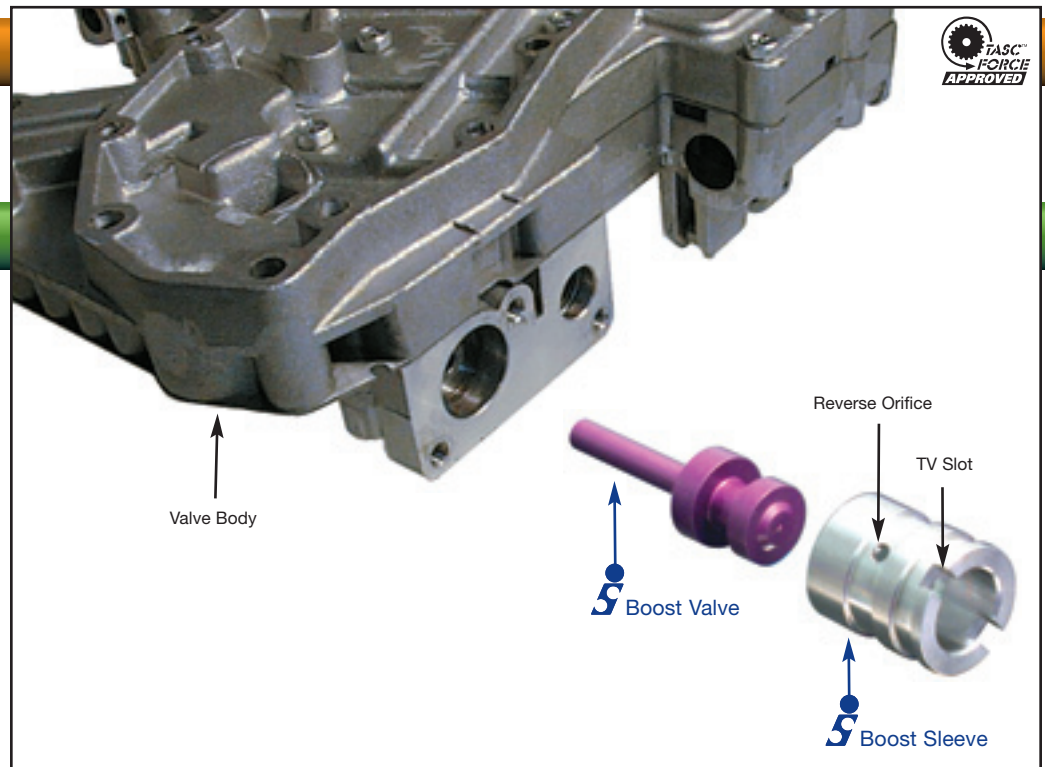
Poor modulator control, delayed reverse

- Soft 1-2 related to poor line rise

A worn boost valve allows TV or reverse oil leakage, thus reducing line pressure rise during increased load.

Vehicles with a L4N71B transmission commonly have poor line rise, soft shifts, and/or poor reverse boost. These complaints are often caused by the reciprocating boost valve wearing the inside diameter of the boost sleeve. When this occurs, oil that enters the throttle valve orifice leaks past the boost valve and exhausts through the reverse orifice, resulting in poor or no line rise. In reverse oil entering the reverse orifice will then leak past the worn sleeve to exhaust, resulting in poor reverse boost. The Sonnax replacement assembly **66942-01K** eliminates these problems with a closely toleranced boost valve and sleeve.

This Sonnax replacement boost valve and sleeve assembly has been manufactured to the larger spool diameters to ensure maximum allowable boost pressure.

- 1 Boost Sleeve
- 1 Boost Valve
