## Differential side gear thrust washer failure

**75890-30**

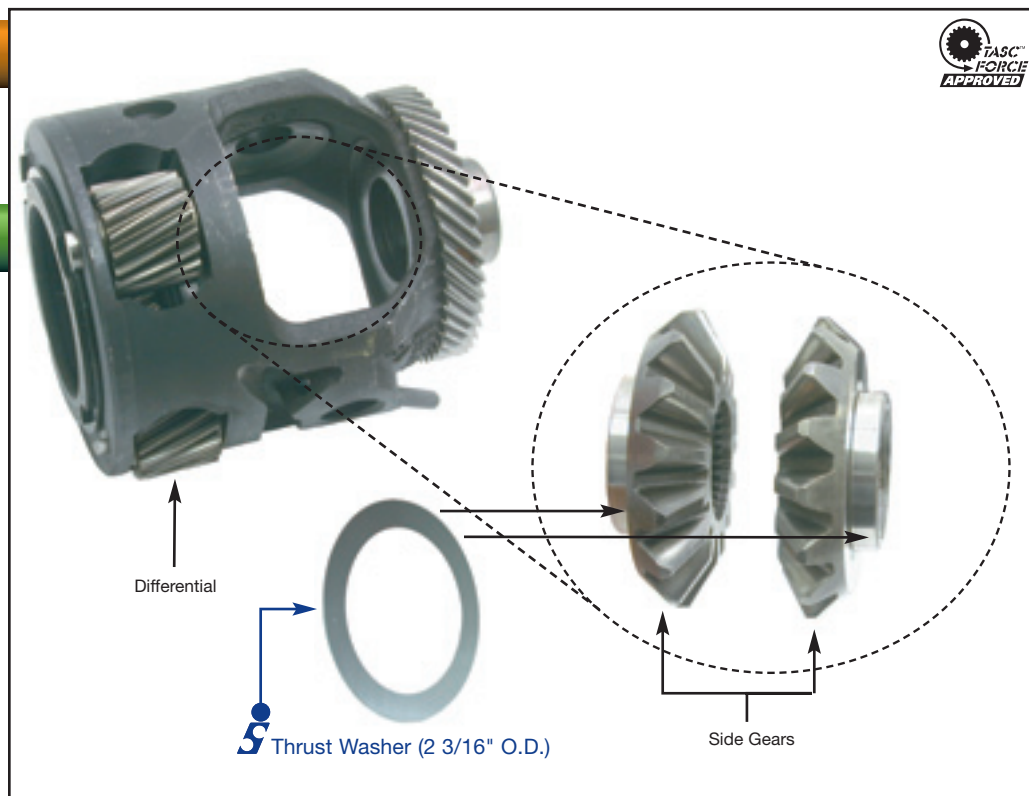
- Washers not serviced separately • Excess differential/axle backlash

Worn side gear thrust washers allow the gears to move away from pinions, causing backlash and clunk.

Hardened thrust washers allow differential salvage and correct set-up.

Sonnax has designed a replacement thrust washer 75890-30 for differentials with 2-3/16" outer diameter washers when these OEM washers get worn or destroyed.
