## Oversized OD Sprag Pilot Bushing

**12509-01**

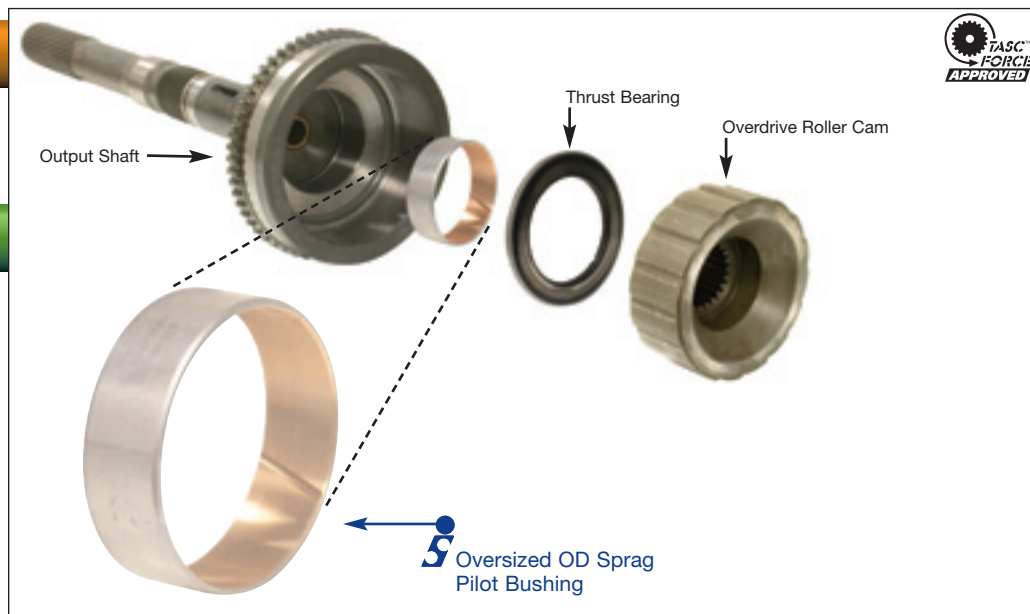
Aftermarket replacement bushings are a poor fit in output shaft housing

Overdrive roller clutch failure

Output shaft housing bore varies in diameter, resulting in inconsistent bushing fit.

The sprag pilot bushing bore found in 1988-up 42-46-47/RH/RE overdrive output shafts can vary in diameter by .011". This variation may result in loose-fitting replacement bushings. You can restore overrunning clutch and output shaft operational clearances by machining the output shaft and installing the Sonnax oversized bushing **12509-01**.

Machine the output shaft bushing housing I.D. and install the Sonnax precision bushing.

**Note:** Installation requires that the output shaft bushing bore be machined oversized.
