Boost Sleeves

Sonnax Part Summary

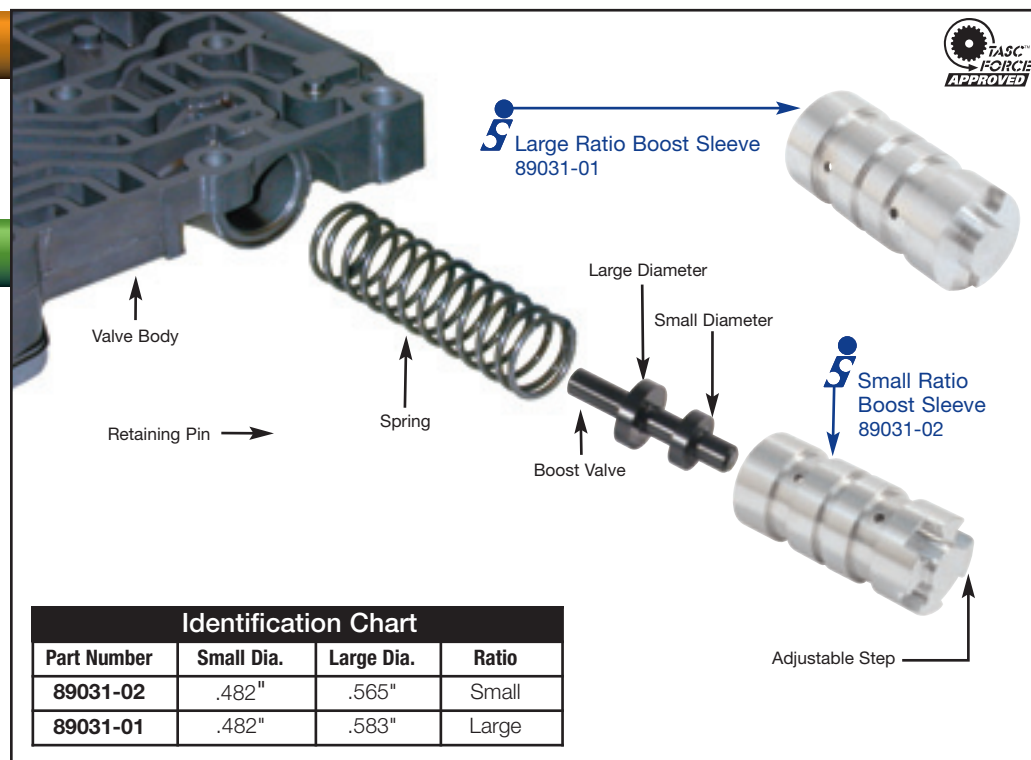
Soft upshifts, delayed reverse

- Higher-than-normal pressures in reverse • Repeated clutch failure

A worn boost sleeve may allow TV pressure to leak to reverse in drive ranges; in reverse, reverse boost oil may leak to the TV circuit.

A severely worn boost sleeve in the A540-E may allow TV pressure to leak into the reverse boost circuit during any valve body drive ranges. This oil is then open to exhaust through the manual valve, resulting in low line pressure. In reverse, reverse boost oil will leak past the worn sleeve and enter the TV circuit. This forces the pressure regulator valve into a higher than normal line pressure position. The Sonnax replacement sleeves **89031-01** and **89031-02** restore the proper clearances and hydraulic integrity.

These replacement boost sleeves will restore hydraulic integrity and prevent leakage and/or cross leaks.
