Torque Converter Clutch Solenoid Snout

65961-01K

Sonnax Part Summary

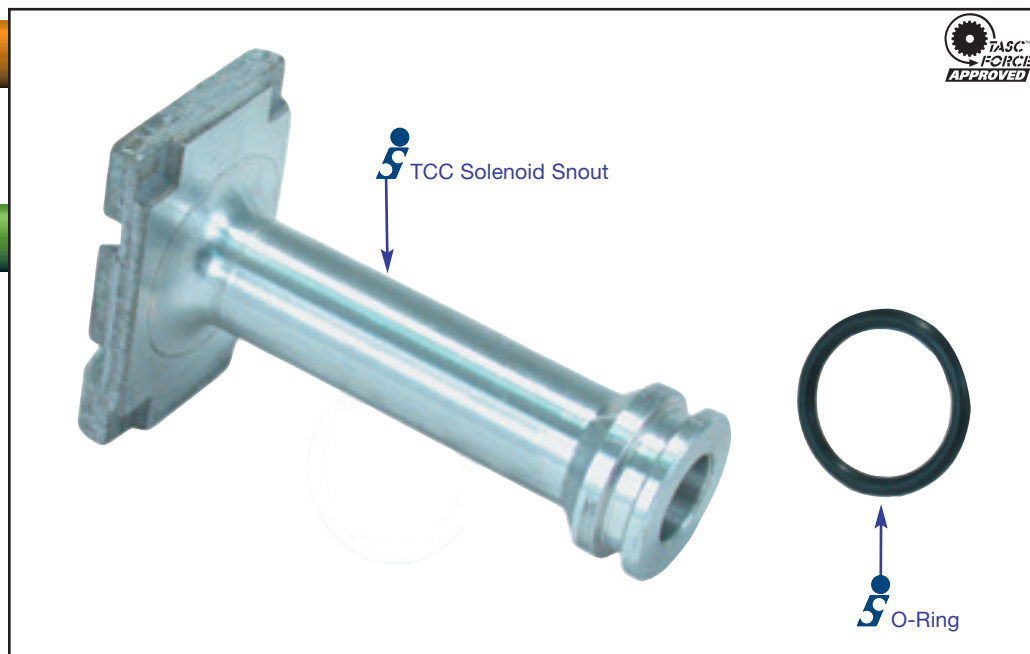
OEM plastic solenoid snout cracks where the plunger valve contacts the snout.

The OEM, plastic torque converter clutch solenoid snouts frequently break, causing them to leak oil that should be directed to the converter clutch apply valve. Until now, the only repair options were to replace the entire OEM wire harness or to purchase an aftermarket solenoid and splice it into the existing wire harness. The new Sonnax solenoid snout **65961-01K** allows the OEM solenoid to be rebuilt to better-than-new condition.

Replace the broken plastic solenoid snout with this aluminum snout.
