Article No.: TCTIP-12-08

More Centerline Issues

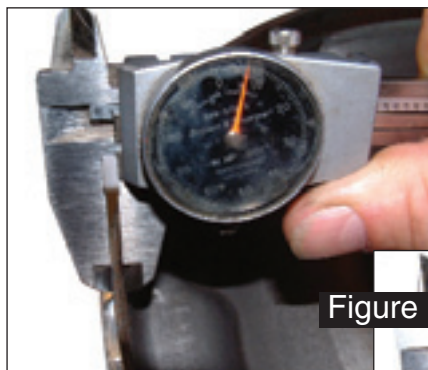
In **Figure 1**, a Chrysler pilot sleeve was mistakenly used when parting this GM converter. The loose piloting allowed an off center condition which resulted in one side of the cut converter being much thinner and lighter than the opposite side. If these components are reused, the converter will require more weight to rebalance.

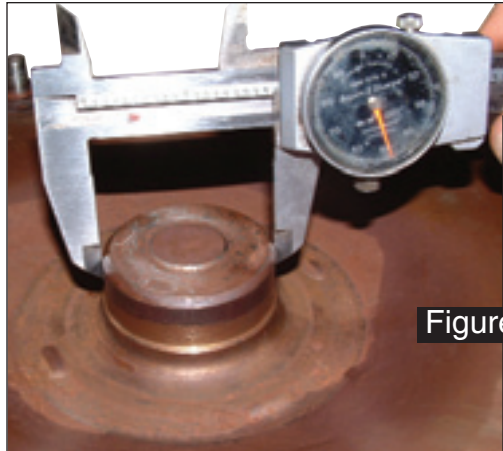
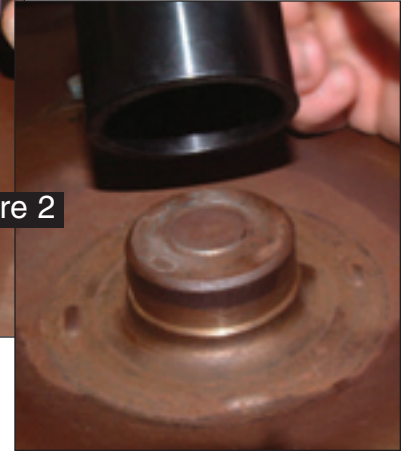
Figure 2

The welding and balancing processes are next to come under scrutiny and both have centerline issues that involve the converter pilot. The turn tables on the welder and balancer each rely on some sort of collet or sleeve to center the converter. Any wear to the collet, sleeve or the pilot itself, will dramatically affect the balance process. The amount of imbalance will vary with the weight and diameter of each converter. For example, a 45 lb 12" diameter converter will need almost $3 \frac{1}{4}$ grams of added weight for each .001" that the converter is off center. The heavier and larger diameter converters will need even more weight to compensate for any off center conditions. For accuracy, each pilot should

be measured individually in at least two places with either calipers or micrometers. You should never rely on a go/no-go gauge to check a pilot.

Following your shop equipment manufacturer's routine maintenance schedule is also very important. This includes checking the run out on your welder and balancer at regular intervals. Tools and equipment that are worn out or are out of calibration can cause multiple issues.
