Boost Valve & Sleeve Kits

Sonnax Part Summary

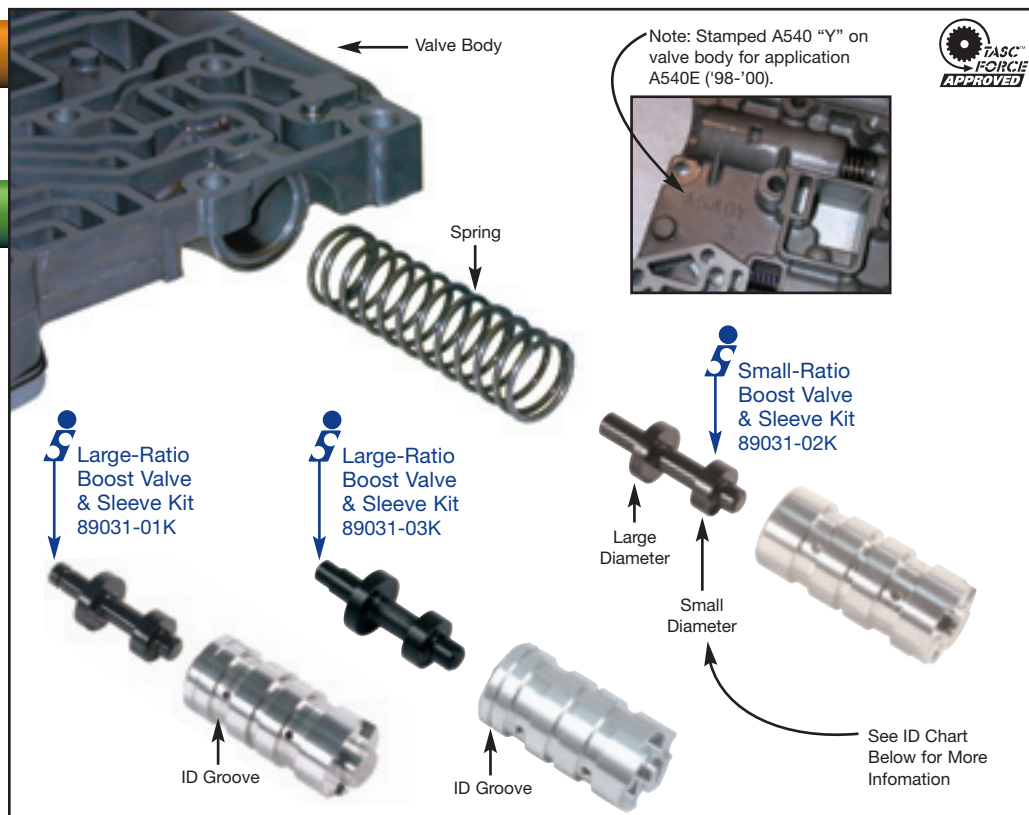
Severe wear of the boost valve assembly allows TV and reverse boost oil leakage.

A severely worn boost sleeve in the A540E may allow TV pressure to leak into the reverse boost circuit during any valve body drive ranges. This oil is then open to exhaust through the manual valve, resulting in low line pressure. In reverse, reverse boost oil will leak past the worn sleeve and enter the TV circuit. This forces the pressure regulator valve into a higher than normal line pressure position. The Sonnax replacement boost valve and sleeve kits **89031-01K**, **89031-02K** and **89031-03K** restore the proper clearances and hydraulic integrity.

The closely toleranced replacement boost valve and sleeve restores hydraulic integrity and prevents oil leakage.
