Oversized Accumulator Pin & Reamer Kit

Sonnax Part Summary

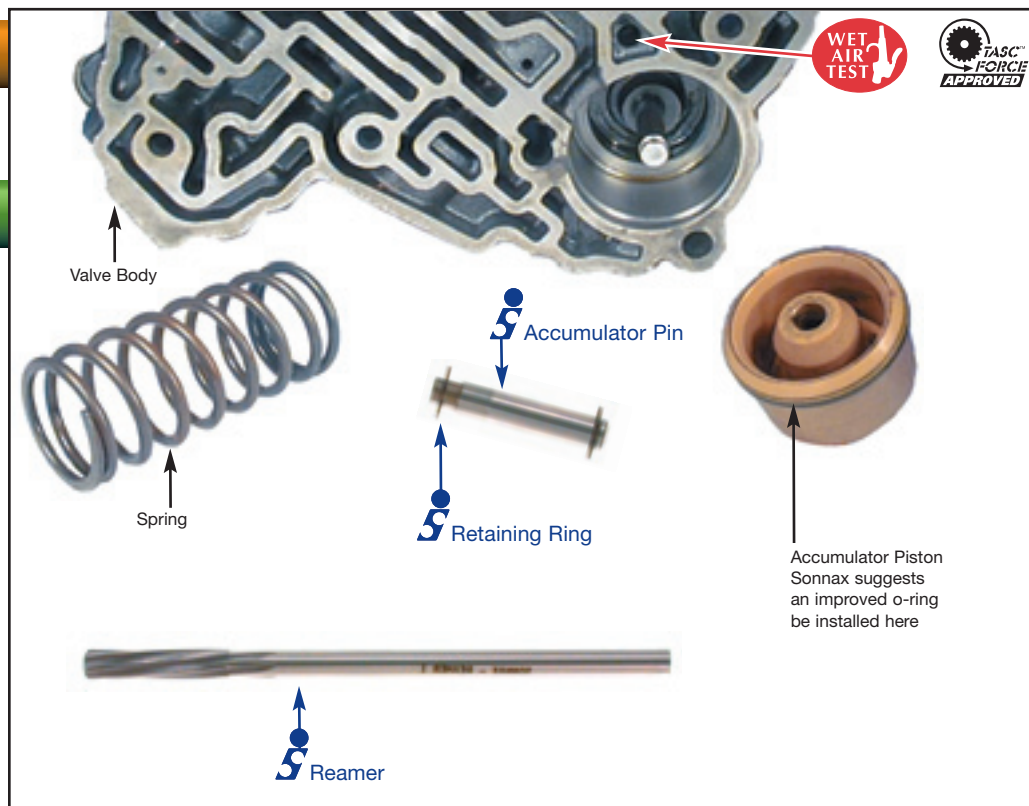
Burned/failed direct clutch

- 2-3 slide shifts

Oil cross leakage and worn accumulator piston pin bore.

A burned or complete failure of the direct clutch on the THM 400 transmission can be created by accumulator cross leaks. A drivability complaint of a long slide on the 2-3 shift can result from excessive piston wear. These complaints can be caused by oil cross leakage between the piston and pin in the front accumulator assembly located in the valve body. Excess wear is due to the constant oscillating motion of the the aluminum accumulator piston on the steel pin. The problem occurs when direct clutch oil and intermediate circuits cross leak. In second gear a cross leak may drag the direct clutch and create premature failure. Install the Sonnax oversized accumulator pin **34105-01K**. Starter kit **34105-02K** contains 10 pins, 10 retaining rings, and 1 reamer.

Restore the bore and re-establish hydraulic integrity with these oversized accumulator pins and reamer for significant savings over replacement parts.

- The diameter of the pin has been slightly oversized, allowing the bore of the accumulator piston to be reamed oversized.
- Kit contains an extra retaining clip to assist in holding the accumulator pin in the valve body.
- Kit restores the hydraulic integrity of the assembly.
