TORQUE FUSE TROUBLE SHOOTING

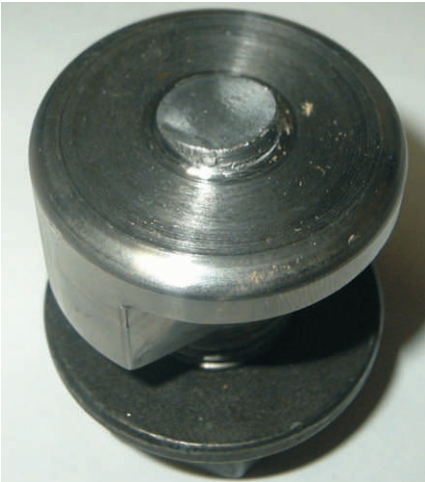
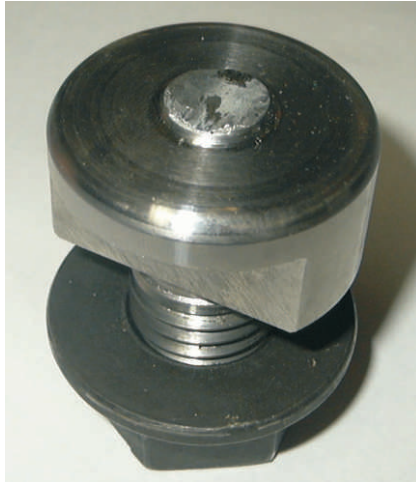
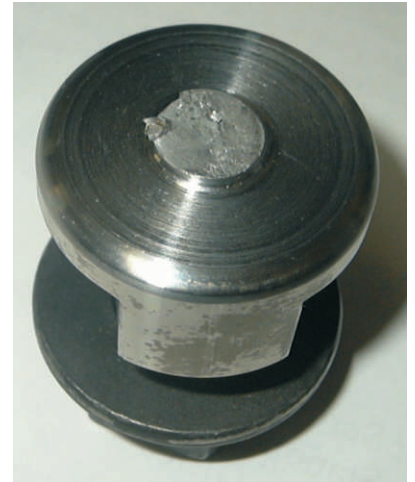
(A) Normal Shear Pattern

(A) Shows a normal shear pattern.

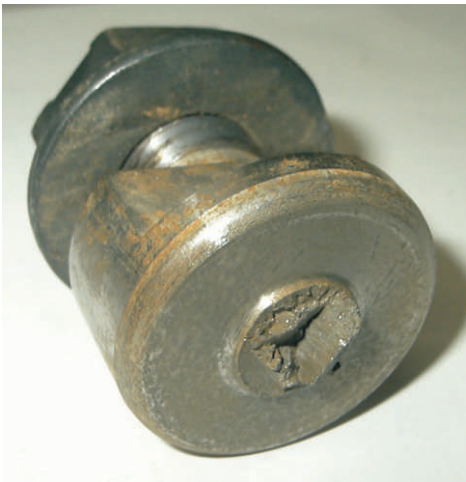
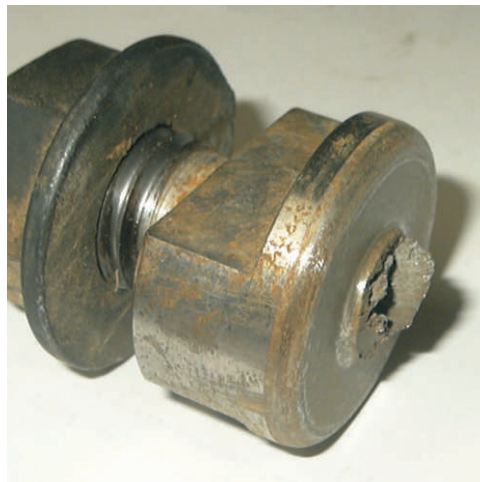
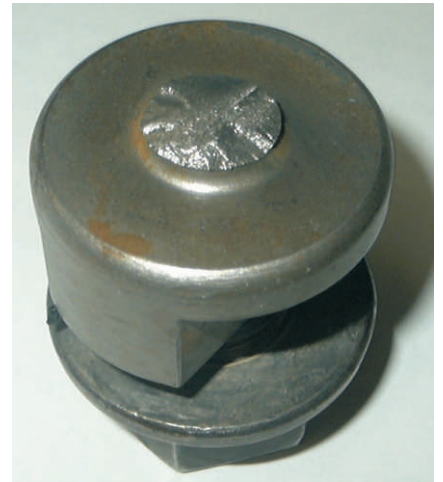
(B) Vibration Shear Pattern

(B) Shows what occurs when drive shaft has a vibration caused by:

1. Improper installation of Power Train Saver

2. Torque Fuses not properly torqued down

(See Installation Instructions Pg. 4 in Parts Catalogue)

(Torque Fuses must be torqued down to 220 Ft/Lbs)
