O-Ringed Modulator Valve End Plug

29133-01K

Sonnax Part Summary

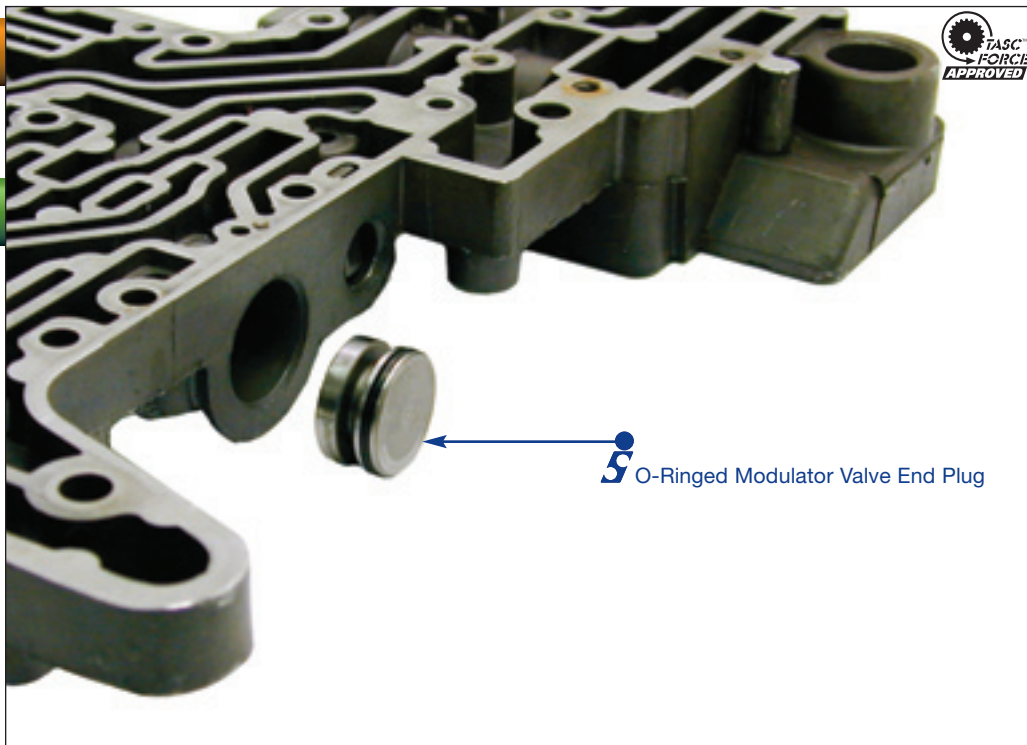
Uncontrollable shift timing

- Loss of governor pressure • Insufficient line rise • Forward clutch failure

Governor oil leakage at the throttle modulator valve end plug due to wear.

Vehicles with a BW-T65/66/35 transmission often have complaints of uncontrollable shift timing, loss of governor pressure, insufficient line rise, and/or forward clutch failure. These complaints are often caused by oil leakage at the throttle modulator valve end plug. If the end plug allows excessive governor oil leakage, there is not enough pressure to properly stroke the modulator valve. Often the TV adjustment is reduced, which allows for earlier shifts, but decreases line rise. This decrease in line pressure and modulator control then results in forward clutch failure. Sonnax now offers a replacement o-ringed end plug **29133-01K**.

Use this replacement o-ringed modulator end plug to prevent valuable oil leakage.

- End plug restores the hydraulic integrity of the circuit.
- O-ring adds protection from excessive leakage.
