Lockup Clutch Control Valve Kit

15741-29K

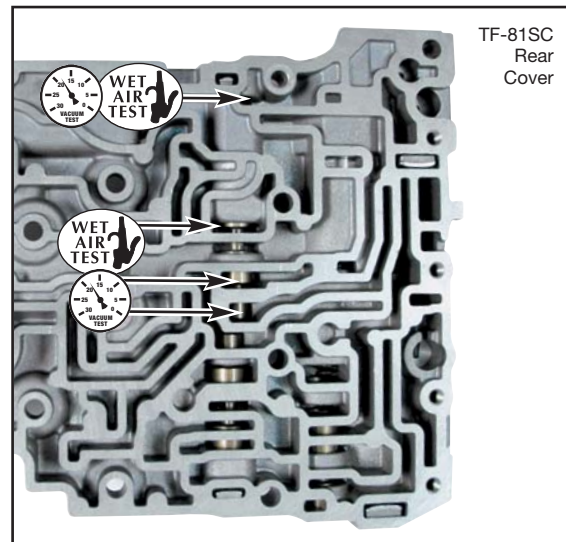
Either a Wet Air Test or a Vacuum Test in the locations shown, result in leakage. A vacuum test must hold a minimum of 18".

Ream the valve bore and install the Sonnax improved valve and sleeve assembly and calibrated spring.
