Unit Endplay Shims

Sonnax Part Summary

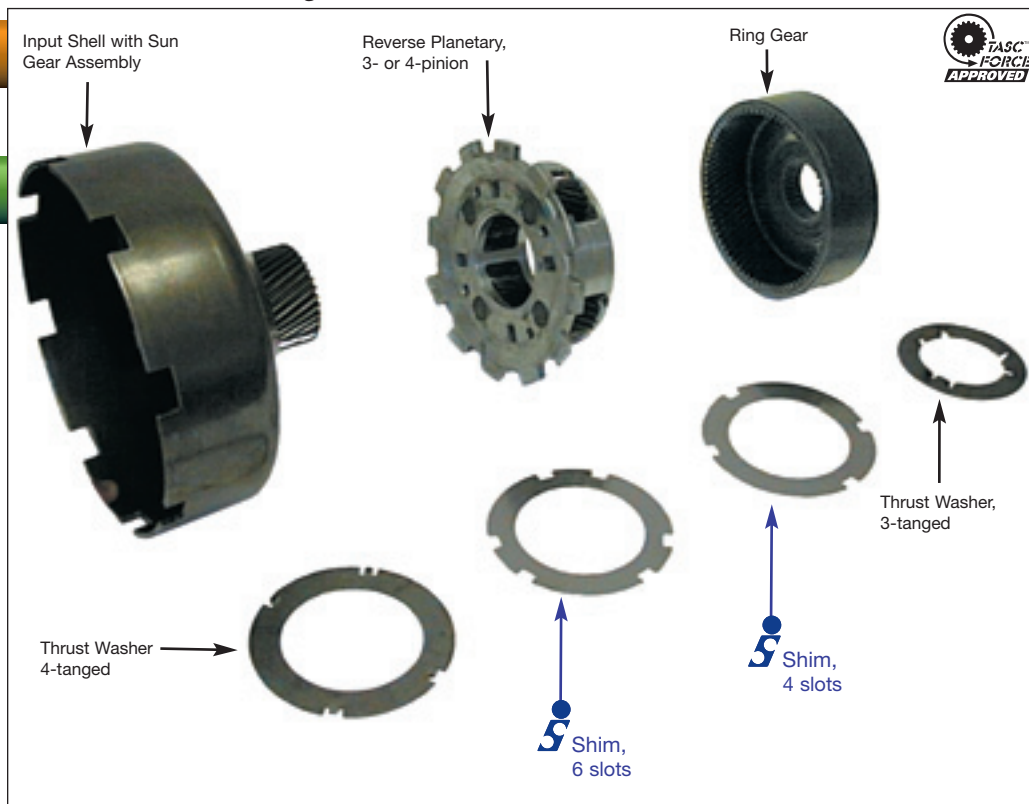
Excessive total unit endplay.

Rear component driveline wear

• Clunk • Reduced seal ring life

It can be difficult to reduce C6 unit endplay with spline or sunshell wear. When driveline wear is excessive, sealing ring and thrust wear increases. As the lower unit wear increases, OEM selective thrust washers are not thick enough to compensate. Rebuilders often try to correct excessive endplay by adding thicker shims to the pump surface, but adding too much shim material to the pump area will push the sealing rings toward a minimal drum contact. Sonnax now offers shims to compensate for driveline wear.

These Sonnax shims allow for proper setting of unit endplay and support the direct drum by supporting the sun gear.

- **36428-Z** is a 6-slotted, .010" thick shim to be used between the 6-tanged thrust washer and 3-pinion rear planetary assembly.
- **36428A-Z** is a 4-slotted, .010" thick shim to be used between the 4-tanged thrust washer and 4-pinion rear planetary.
- These shims, together with OEM thrust washer material, will allow precise endplay adjustment.
