Reverse drum, retainer and planet failure

Upgraded Piston Retainer

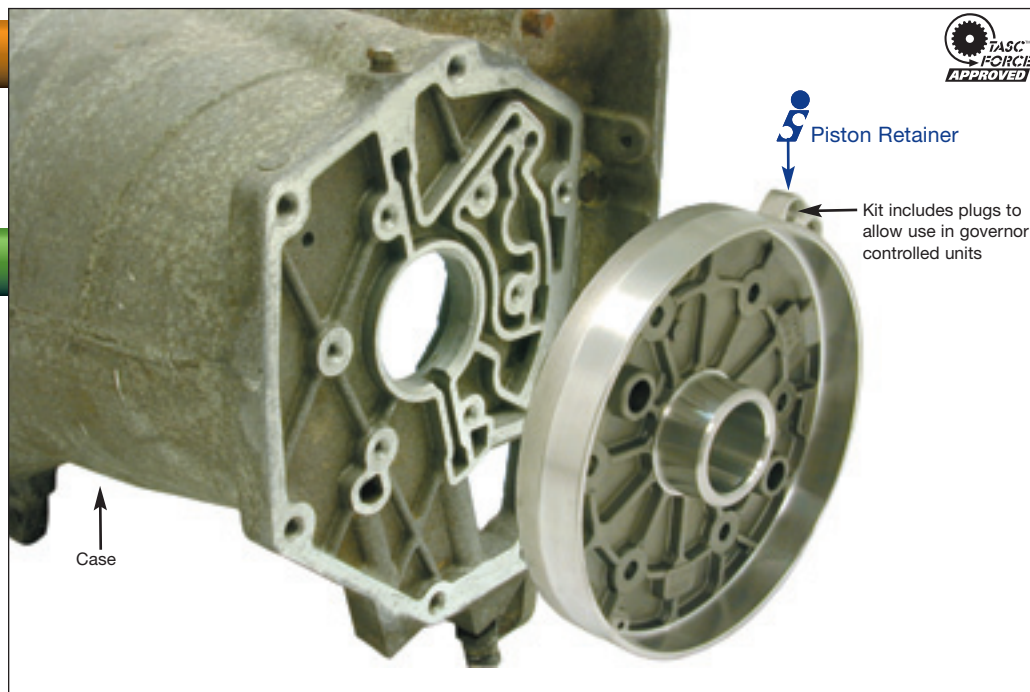
- Loss of lube oil to the gear train

Excessive clearance between the over-drive piston retainer and intermediate shaft reduces lube flow to the gear train.

Seal compensates for variations in case I.D. Oil is delivered to maximum load points on shaft. Optional oversized reverse drum journal allows salvage of reverse drum.

Allows damaged reverse drum to be machined and salvaged.
