Main Pressure Regulator & Boost Assembly

15741-01K

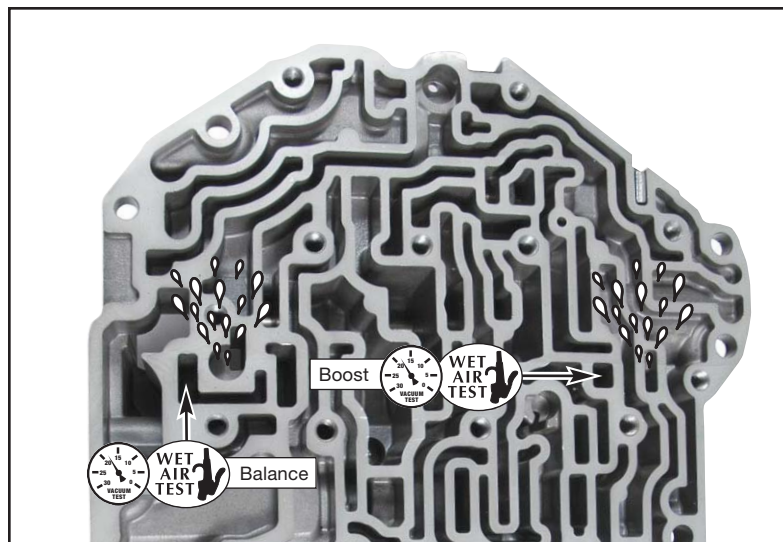
Either a Wet Air Test or a Vacuum Test in the two locations shown, result in leakage. A vacuum test must hold a minimum of 18".
