Accumulator Bore Sleeve Kits

Sonnax Part Summary

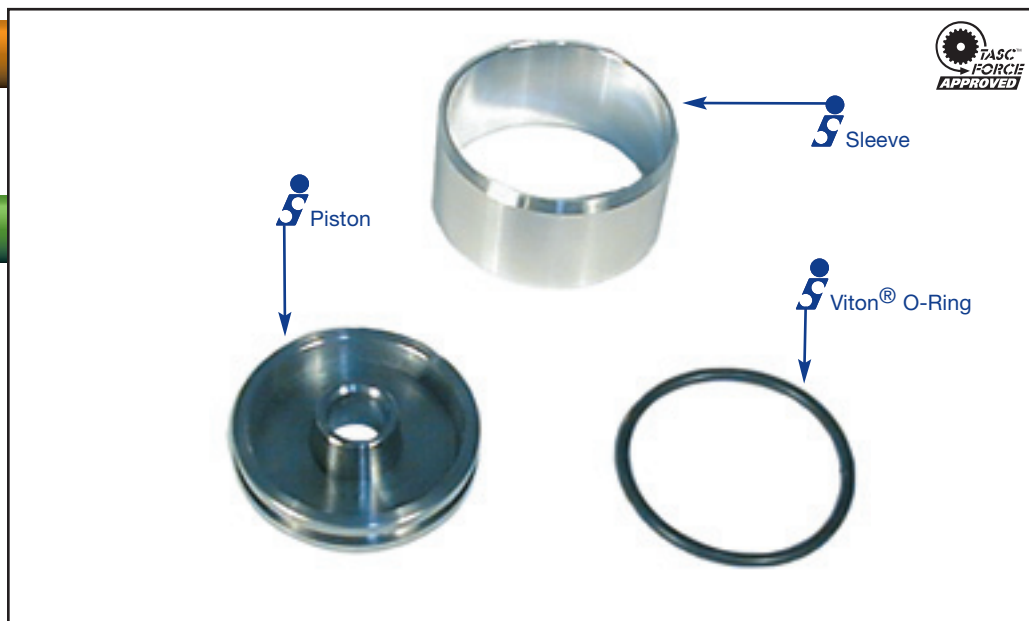
Delayed engagements, flare shifts

- Harsh shifts

Scored accumulator bores create loss of clutch pressure or cross leaks.

The accumulator bores on AXOD & E, AX4S channel castings can become scored, which creates loss of clutch pressure or cross leaks. The continuous oscillation of the piston within the bore causes excessive wear. Also a broken accumulator spring can get caught between the piston and the bore causing a deep groove in the casting wall. You can resolve these problems by installing these Sonnax AXOD & E, AX4S accumulator bore sleeve kits.

The accumulator bore sleeves are made from wear-resistant aluminum and the length of the piston-to-pin contact area has been increased to reduce piston cocking and increase sealing surface area.
