Oversized 1-2 Accumulator Valve

84754-57K

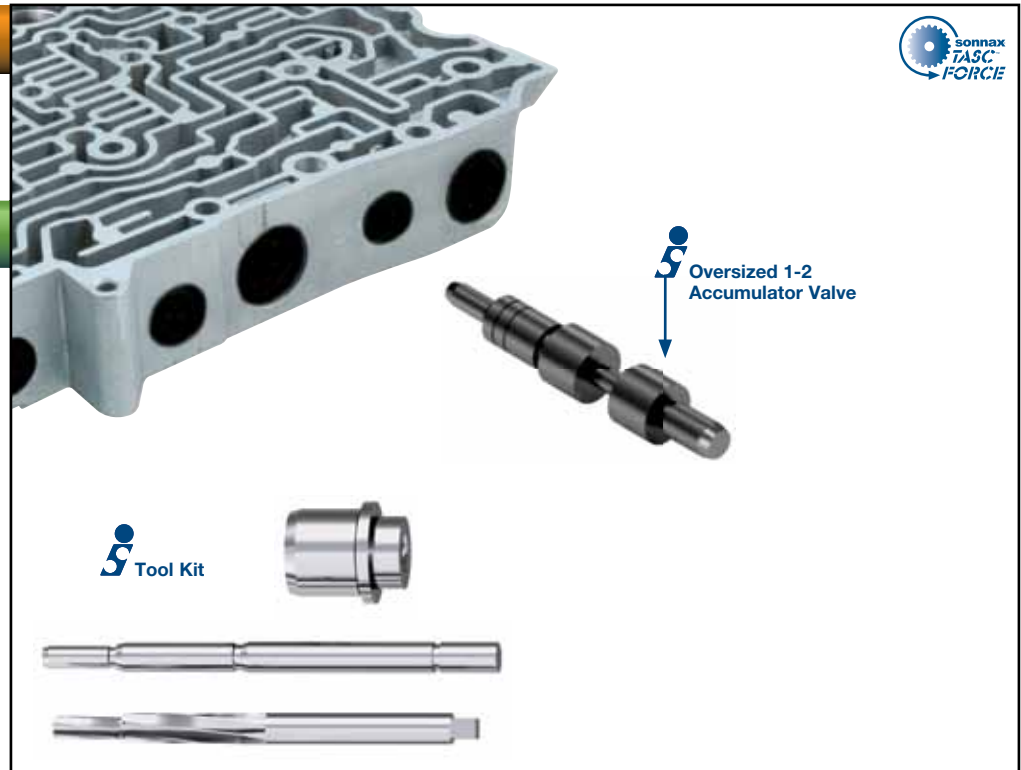
Valve

Wear at the 1-2 accumulator valve and/or bore, allowing loss of torque signal, 1-2 accumulator and/or line pressure.

Refurbish the worn bore and install the Sonnax oversized valve to restore correct hydraulic clearances.
