## Torque Fuse Troubleshooting

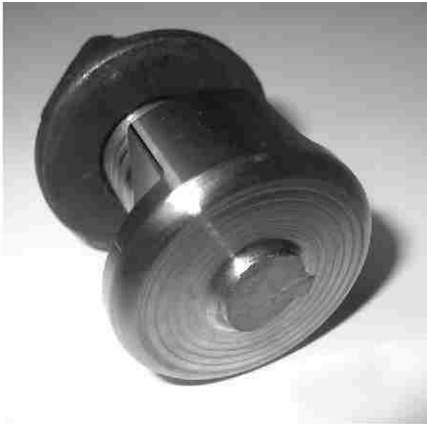
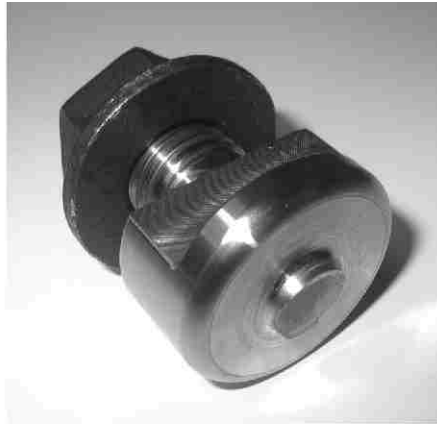
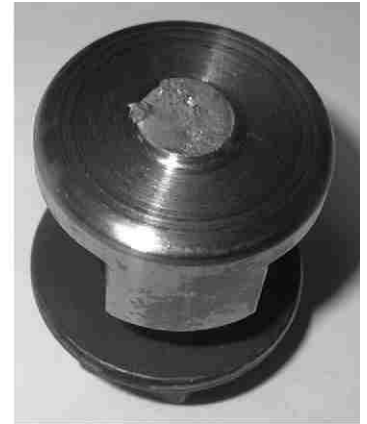
### (A) Normal Shear Pattern

(A) Shows a normal shear pattern.

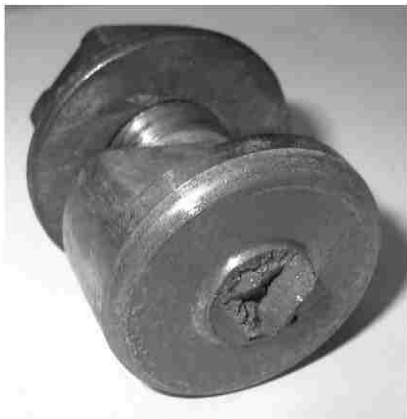
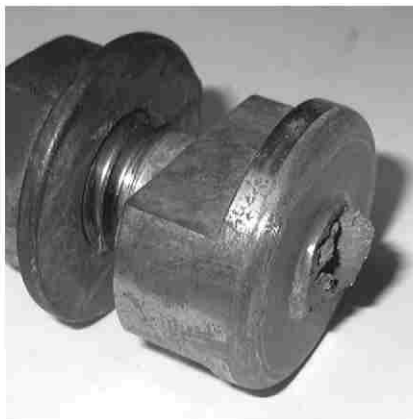
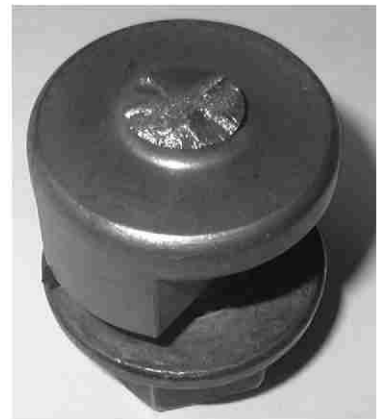
### (B) Vibration Shear Pattern

(B) Shows what occurs when drive shaft has a vibration caused by:

1. Improper installation of Power Train Saver  
(See Installation Instructions Page 4 in Parts Catalogue)
2. Torque Fuses not properly torqued down  
(Torque Fuses must be torqued down to 220 Ft/Lbs)
