Oversized Manual Valve

36940-11

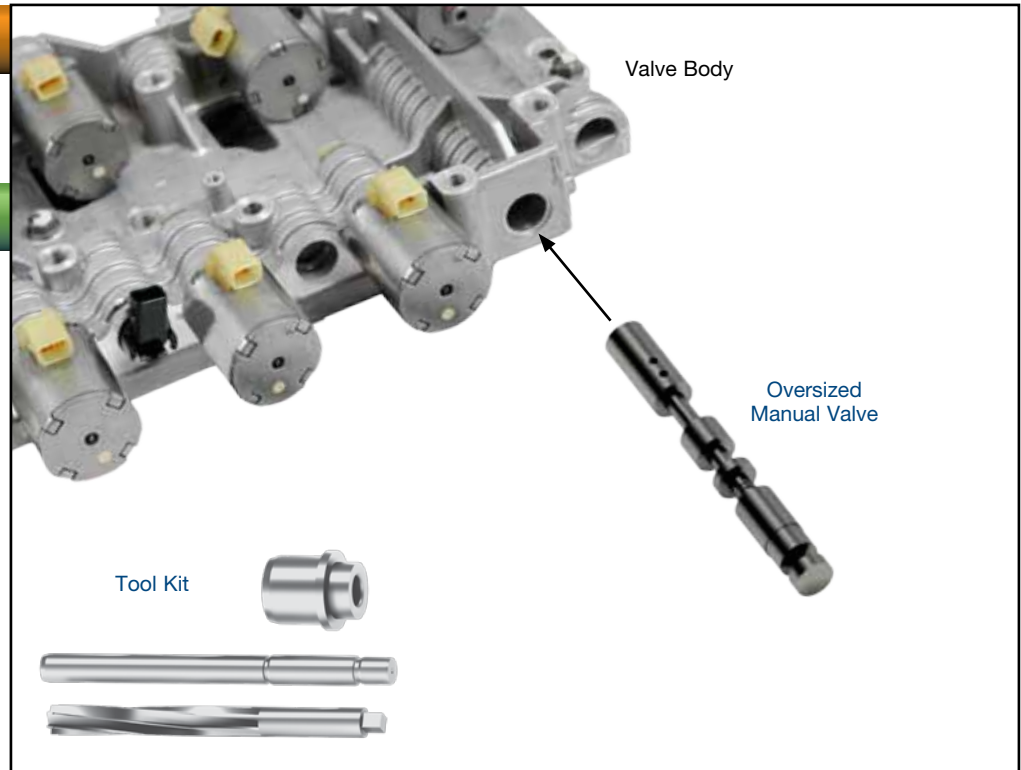
Reduced line pressure

- Delayed drive/reverse engagement
- Loss of valve body core

Valve and/or bore wear due to linkage side loads and/or extended service life.

A visual inspection indicates wear at the low/reverse clutch circuits (the land between the two most outboard circuits), or wear at the line pressure/direct clutch circuits (the land between the two most inboard circuits). Obvious wear of the valve spools at the locations discussed above indicates wear in the bore.

Ream the bore oversize and install oversized manual valve.
