## COMPLAINT

## Soft upshifts, delayed reverse

## Boost Valve & Sleeve Kits

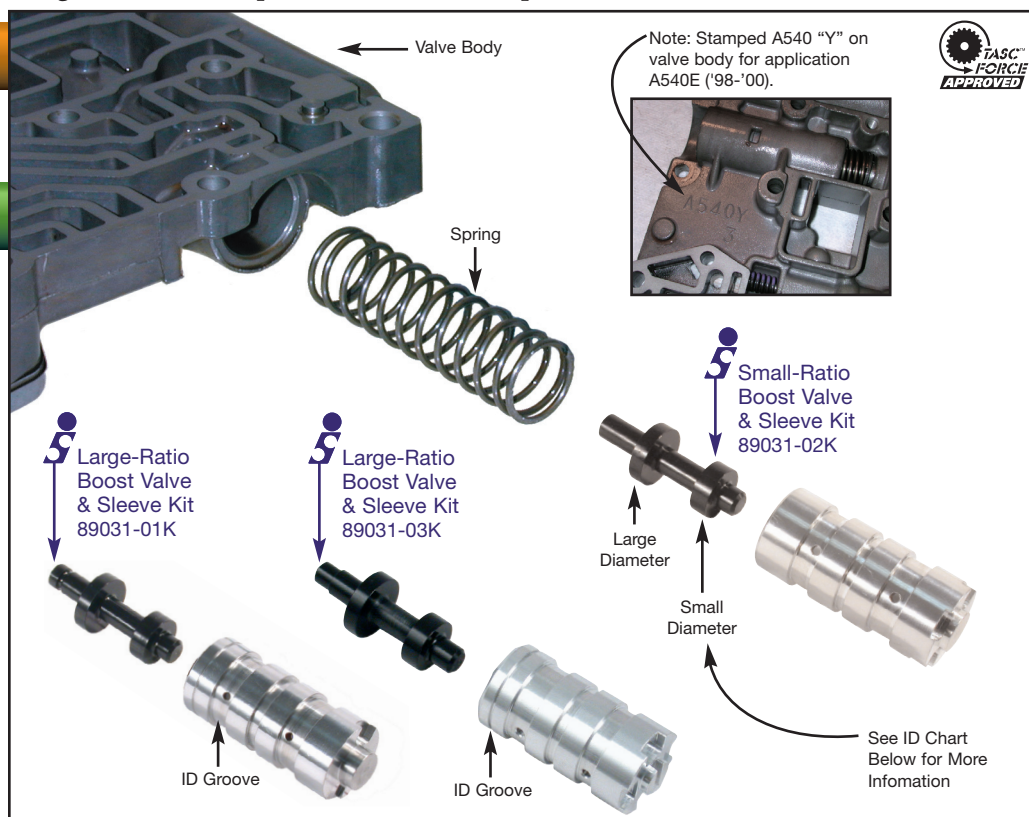
Severe wear of the boost valve assembly allows TV and reverse boost oil leakage.

A severely worn boost sleeve in the A540E may allow TV pressure to leak into the reverse boost circuit during any valve body drive ranges. This oil is then open to exhaust through the manual valve, resulting in low line pressure. In reverse, reverse boost oil will leak past the worn sleeve and enter the TV circuit. This forces the pressure regulator valve into a higher than normal line pressure position. The Sonnax replacement boost valve and sleeve kits **89031-01K**, **89031-02K** and **89031-03K** restore the proper clearances and hydraulic integrity.

The closely toleranced replacement boost valve and sleeve restores hydraulic integrity and prevents oil leakage.
