## 1-2 Accumulator Sleeve & Piston Kit

### 96803-01K

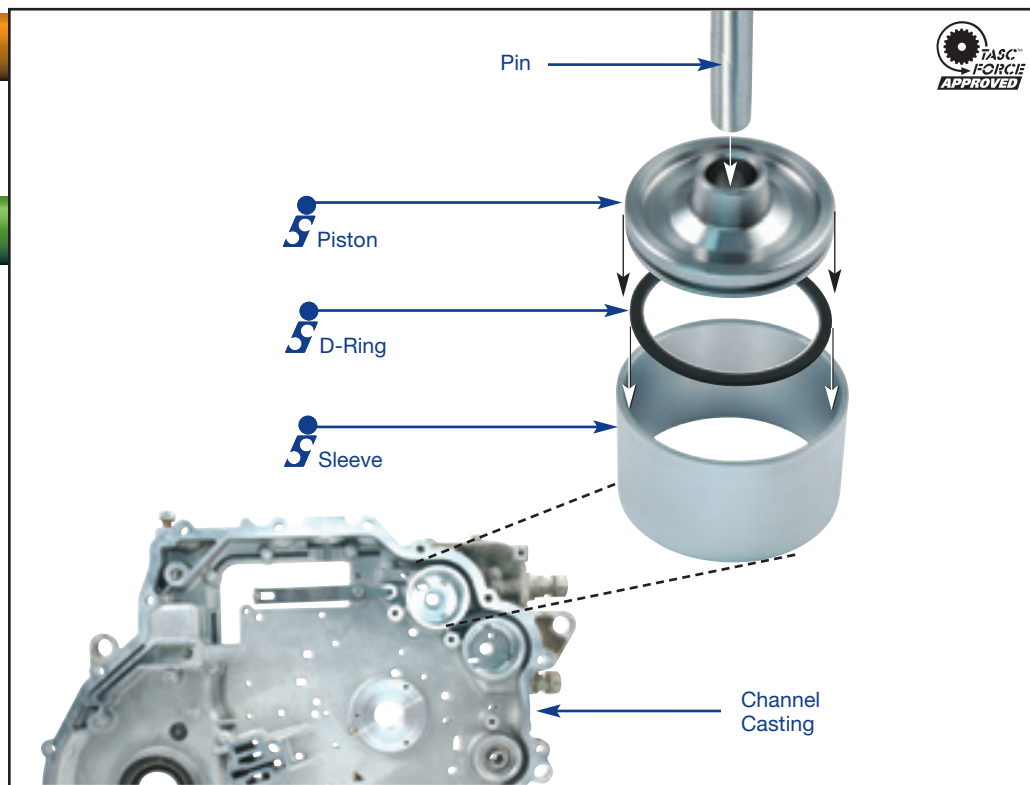
Wear and scoring of the 1-2 accumulator piston bore due to constant oscillation causes loss of 2<sup>nd</sup> clutch pressure.

This accumulator sleeve and piston with D-ring is a simple drop-in solution that allows cases with worn bores to be salvaged.
