## COMPLAINT

## Flare upshifts or downshift bind-ups

## K1 Clutch Control Valve Kit

### 25741-25K

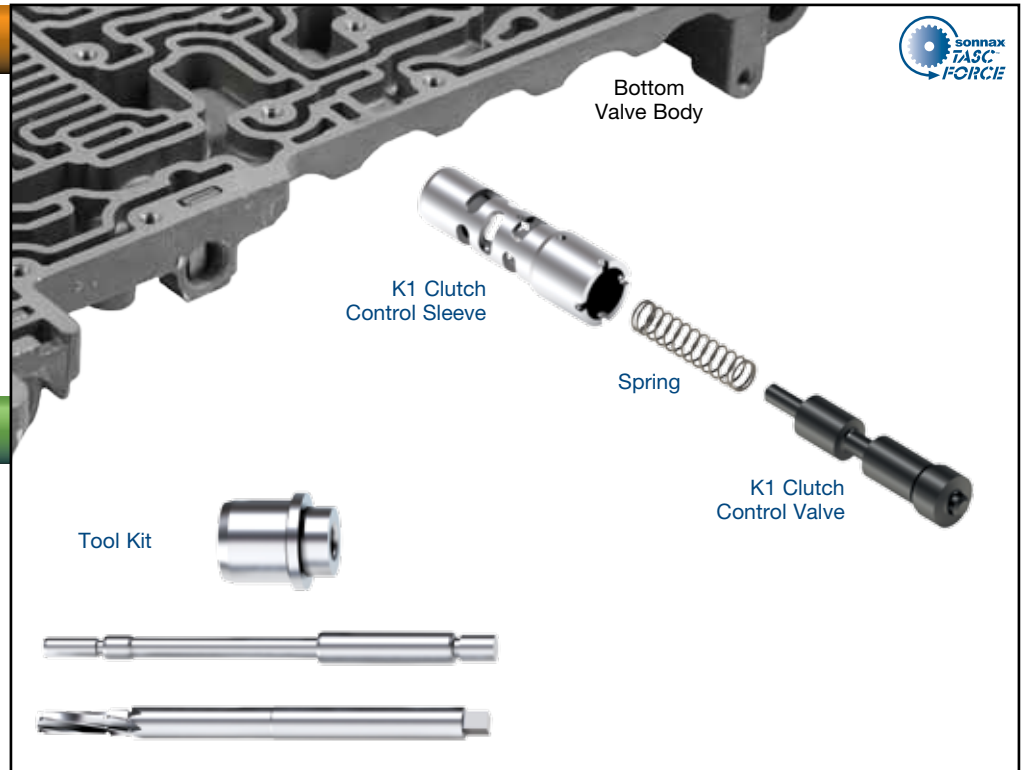
Bore wear at the K1 clutch control results in delayed engagement into drive, flare on 4-5 upshift and harsh 5-4 coast downshift. This bore wear will cause a clutch overlap condition (bind-up) or premature exhaust of clutch pressure (flare). Installing the Sonnax K1 clutch control valve kit 25741-25K will correct source pressure and clutch control timing.

The Sonnax wear-resistant sleeve and valve correct circuit pressure loss and restore control timing of the K1 clutch control valve.

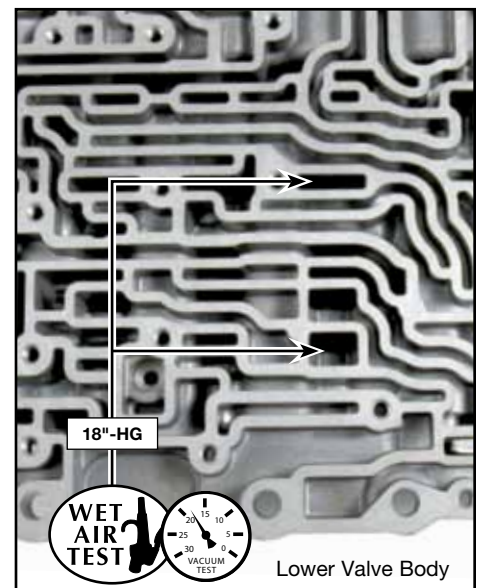
A vacuum test at the indicated ports fails to yield 18 in.-hg or greater, or if visual wear is detected.
