## Rear Planet Endplay Shims

### 22700-Z

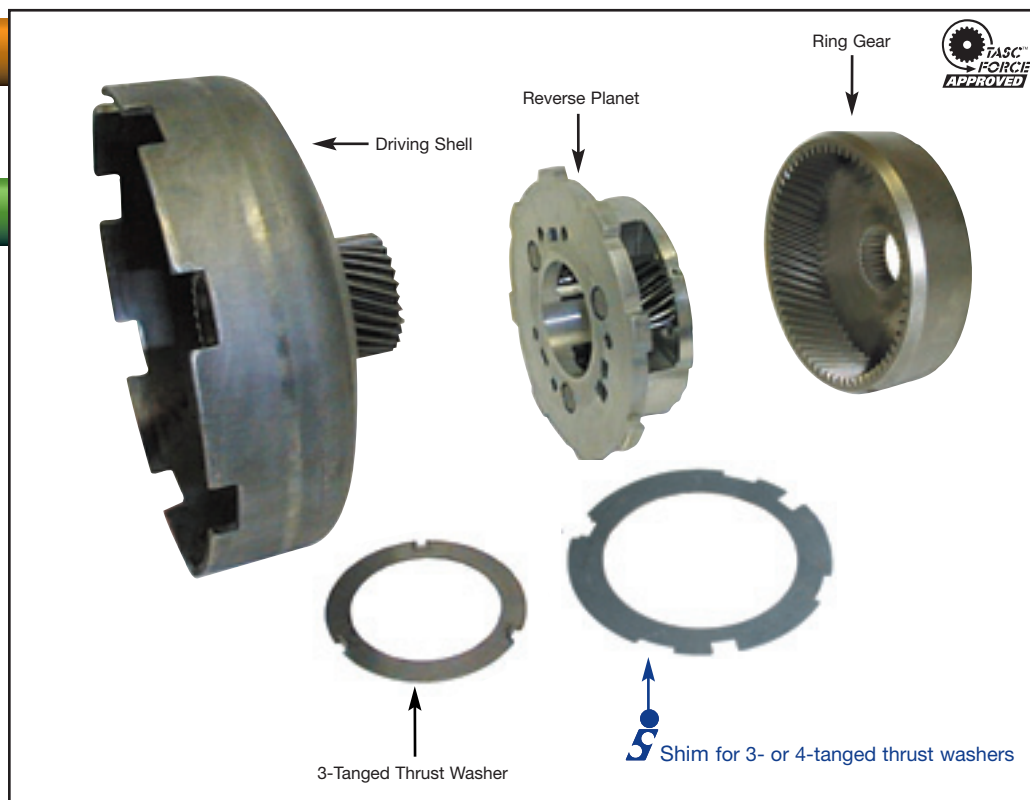
Excessive total transmission endplay

Endplay due to worn gears, snap rings, and/or splines.

This shim reduces transmission endplay for 3- or 4-tanged OEM washers.

10 Shims (.010" thick)
