K3 Clutch Control Valve Kit

25741-08K

Flare upshifts or downshift bind-ups in vehicles with the Aisin AW TR-60SN, VW/Audi 09D transmission can be caused by a worn K3 clutch control valve. Wear at this valve causes incorrect shift timing, which can also cause clutch distress. The Sonnax K3 clutch control valve kit 25741-08K helps restore shift timing.

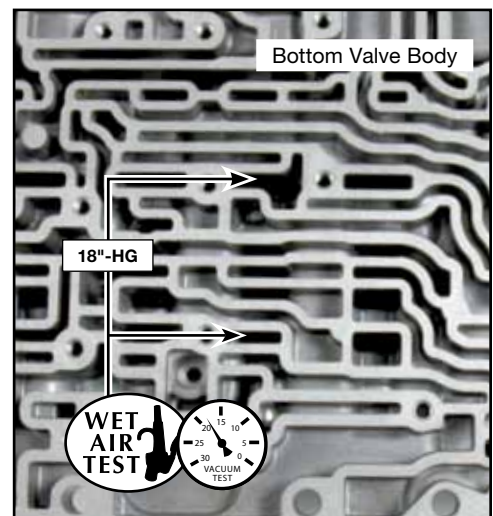
The K3 clutch control valve provides source pressure for control of clutch apply and release. Responding to TCU and the linear solenoid, the K3 control valve will establish control timing of apply and release relative to engine torque. Bore wear can cause either an overlap and bind-up or premature exhausting of clutch pressure, resulting in a flare shift.

A vacuum test at indicated ports fails to yield 18 in-hg or greater, or if visual wear is detected.

The Sonnax wear resistant sleeve and valve corrects circuit pressure loss and restores control timing of the K3 clutch.
