Oversized Accumulator Pin & Reamer Kit

Sonnax Part Summary

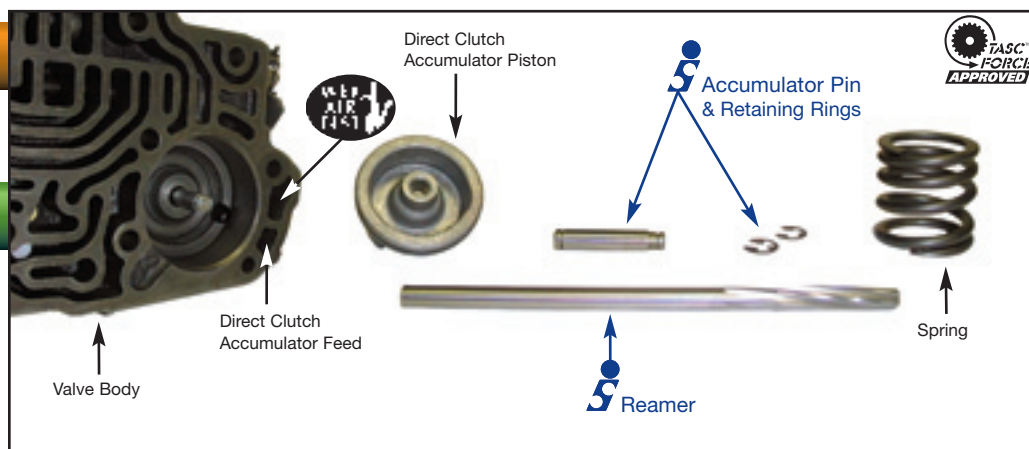
Burned/failed direct clutch and 2-3 slide shifts

Oil cross leakage at a worn accumulator piston bore pin.

A burned or complete failure of the direct clutch on the THM 350 transmission can be caused by accumulator cross leaks. These problems can be caused by oil cross leakage between the piston and pin in the direct clutch accumulator assembly located in the valve body. This is due to the constant oscillating motion of the aluminum accumulator piston on the steel pin. The problem occurs when direct clutch oil and intermediate oil circuits cross leak. Install the Sonnax replacement accumulator pin kit **35718-01K** to address these complaints.

The oversized accumulator pin allows the piston pin bore to be reamed to restore hydraulic integrity.

- The working diameter of the pin is slightly oversized, allowing the bore of the accumulator piston to be modified to restore the hydraulic integrity of the assembly.
- Kit contains an extra retaining clip to assist in holding the accumulator pin in the valve body, which is much less expensive than replacing the accumulator piston and more durable than a bushing.
- Starter kit **35718-02K**, also available, includes 10 pins, 20 rings and one reamer.
