Damaged stator support turbine shaft sleeve

Stator Support Sleeve

34203-01K

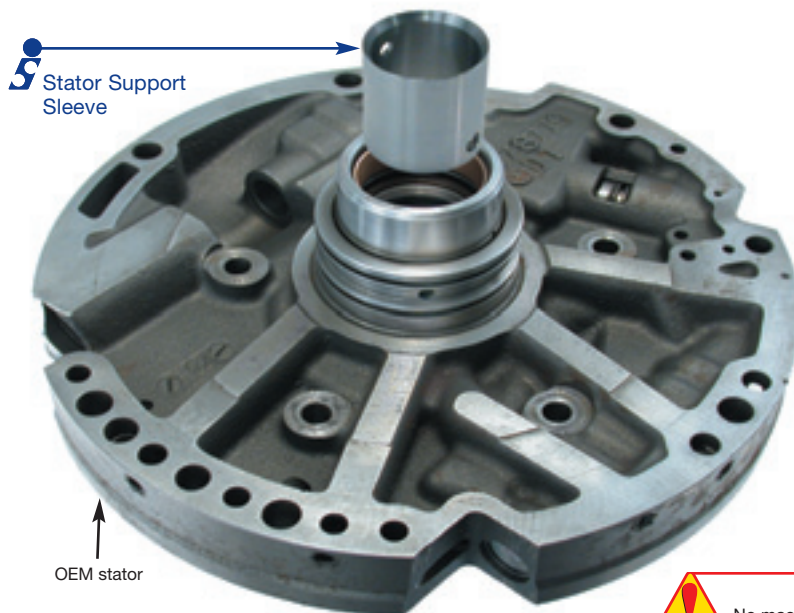
Sealing ring contact, worn stator support bushing, or turbine shaft breakage.

This stator support sleeve salvages damaged stator supports and restores the sealing ring surface for the turbine shaft.

The sealing ring surface on the turbine shafts in 4L80-E units can wear because of sealing ring contact, worn stator support bushings or shaft breakage. Sonnax offers a stator support sleeve, **34203-01K**, that salvages the stator supports and restores the sealing ring surface for the turbine shaft. This sleeve is a direct replacement for the OEM sleeve, and does not require any machining to install.
