COMPLAINT

2-3 Shift Complaints

2-3 Accumulator Valve Kit

84754-53K

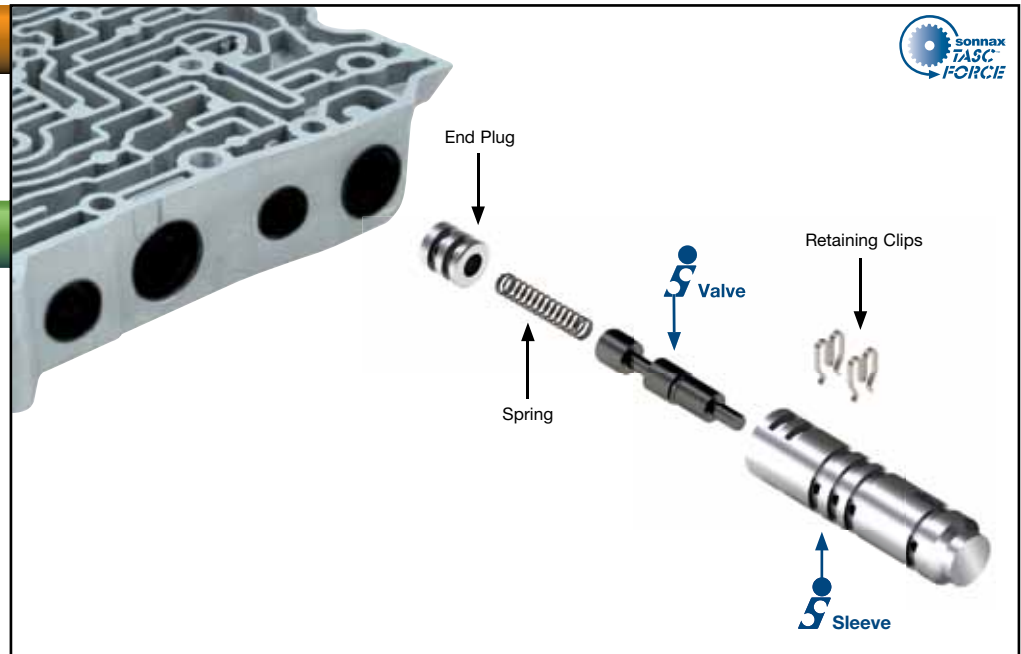
- Poor line rise

Wear of the 2-3 accumulator valve and/or sleeve allow loss of torque signal, 2-3 accumulator and/or line pressure.

To help control the 3rd clutch apply pressure and shift feel, a 2-3 accumulator piston and an accumulator valve and sleeve that regulate fluid pressure are used. The 2-3 accumulator valve and sleeve regulate line pressure using torque signal influence and direct 2-3 accumulator pressure to the spring side of the piston, controlling the 3rd clutch apply. Wear at the sleeve or valve can allow torque signal, 2-3 accumulator or line pressures to exhaust, resulting in various 2-3 shift complaints. Some early OEM valves were not anodized, and are prone to significant wear and scratching.

A vacuum test at either port indicated fails to hold 18" of vacuum or higher, or if visual wear is detected at the inboard overlap valve bores.

Install the Sonnax valve and sleeve kit that has upgraded materials, restores correct hydraulic clearances and is designed to prevent wear.

The Sonnax replacement valve and sleeve kit **84754-53K** is made to the late OEM size ratio for increased torque signal influence, and can be used in early valve bodies as well. Upgraded materials and design have been incorporated to prevent wear.
