Pump Shaft Bearing with Seal

33000-01

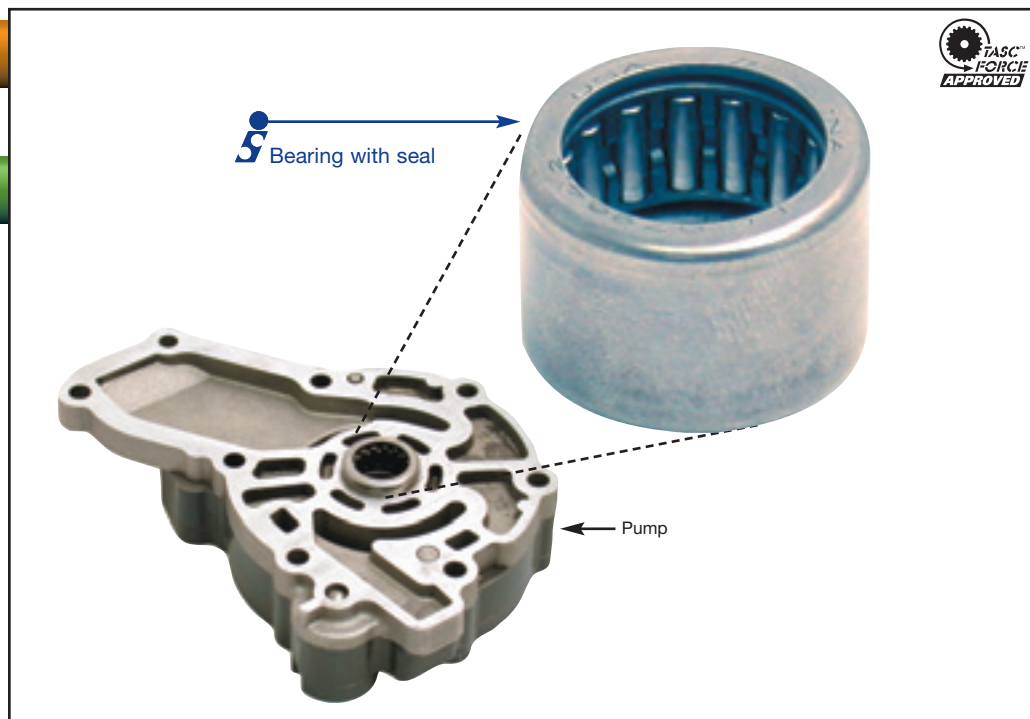
1 Pump Shaft Bearing

Pump bearing or seal failure

Normal wear causes parts to fail.

Bearing and pump shaft wear are common causes of unit failure in 4T40-E transmissions. When the integral seal is damaged, pump oil pressure will cross leak into the TCC release circuit, triggering TCC stuck on codes when TCC is not applied, and causing TCC slip codes when TCC is applied. Sonnax now offers **33000-01**, a direct replacement pump bearing with integral seal. We recommend that you replace this part in every overhaul.

This replacement bearing is a direct replacement for the OEM bearing.
