Boost Sleeves

Sonnax Part Summary

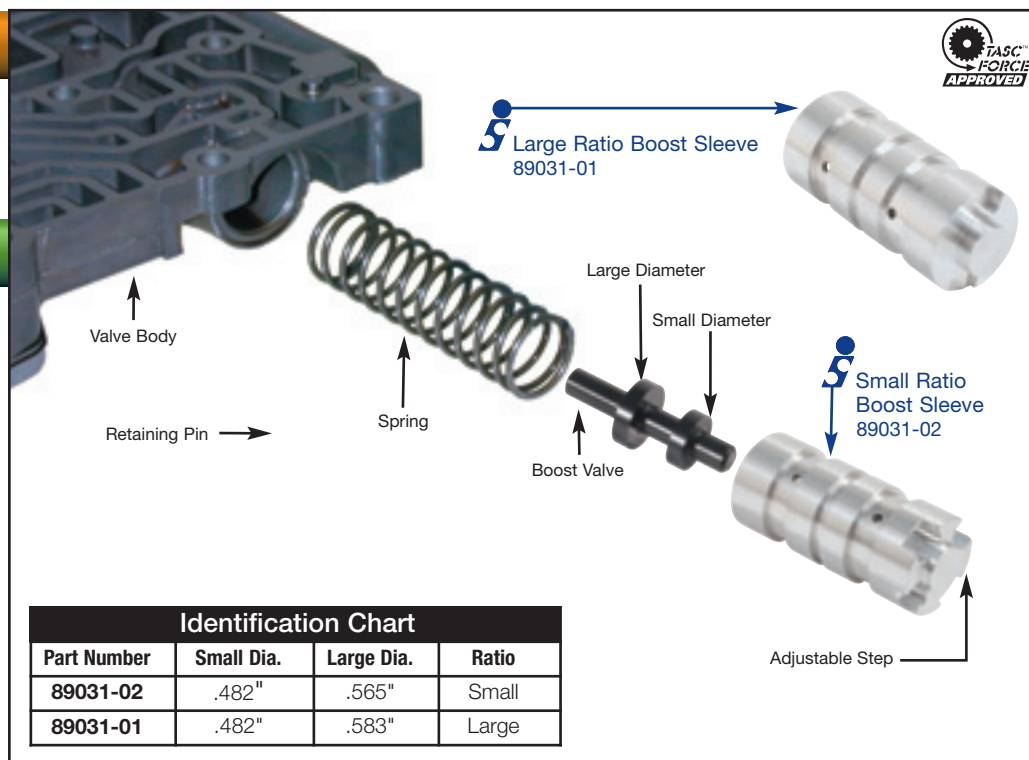
A severely worn boost sleeve in the A540-E may allow TV pressure to leak into the reverse boost circuit during any valve body drive ranges. This oil is then open to exhaust through the manual valve, resulting in low line pressure. In reverse, reverse boost oil will leak past the worn sleeve and enter the TV circuit. This forces the pressure regulator valve into a higher than normal line pressure position. The Sonnax replacement sleeves **89031-01** and **89031-02** restore the proper clearances and hydraulic integrity.

These replacement boost sleeves will restore hydraulic integrity and prevent leakage and/or cross leaks.
