3-4 Accumulator Spring

12861-01

Sonnax Part Summary

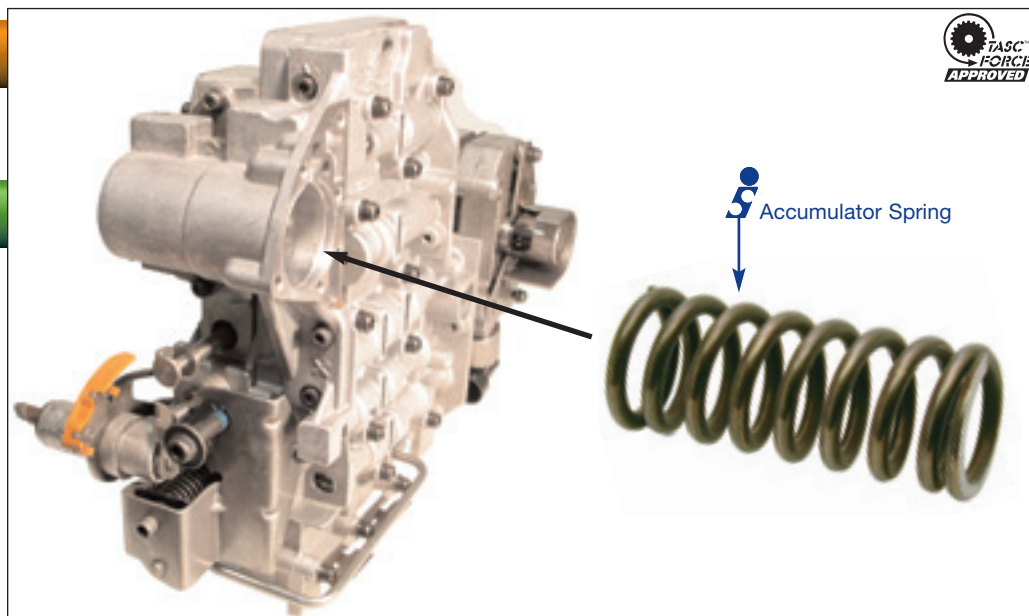
Sluggish shifts

Fatigued OEM 3-4 accumulator springs.

In vehicles with 42-46-47RH/RE transmissions, it is common for the 3-4 accumulator spring to fatigue, causing sluggish shifts, or to break. Sonnax now offers a specially designed 3-4 accumulator spring **12861-01** to restore the proper shift feel.

This 3-4 accumulator spring re-establishes proper shift feel in these transmissions. This is a duplicate of OEM diesel application 47RE.
