# 1870 DTC, TCC, AFL, PWM, EC<sup>3</sup>, etc.

By Maura Stafford

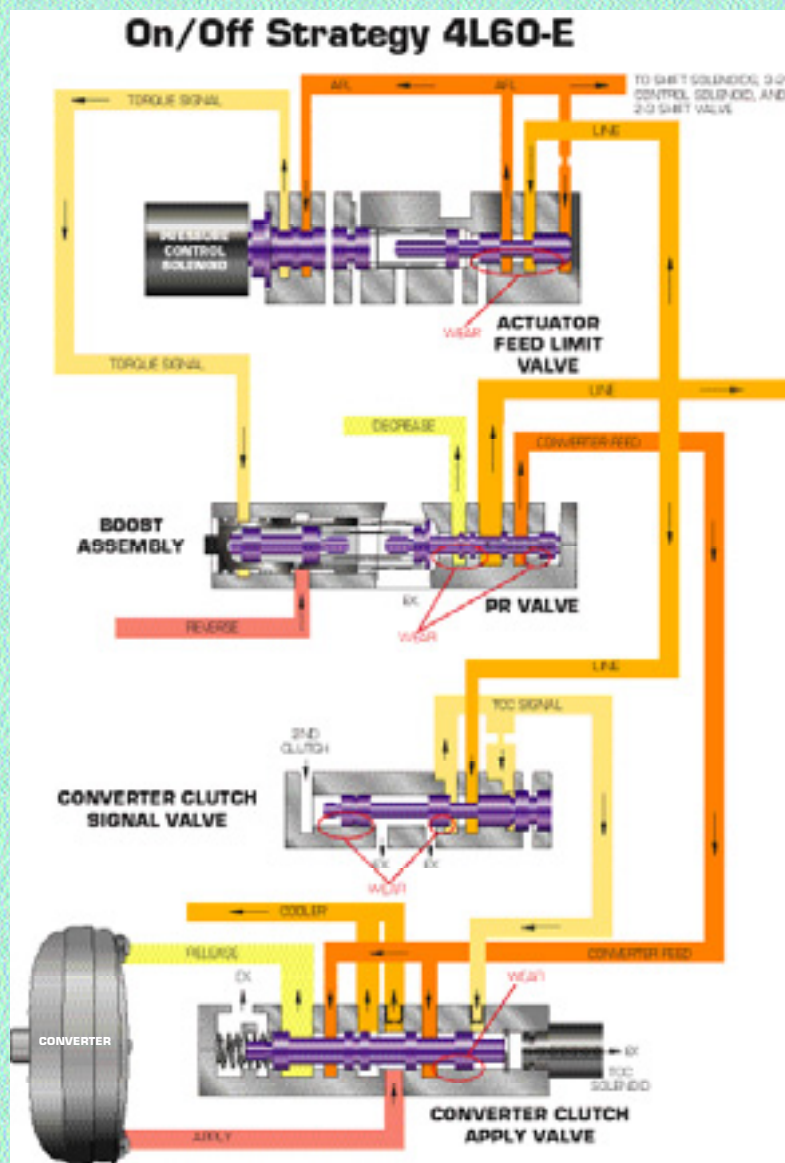
Figure 1

The On/Off strategy (Figure 1) operates the converter clutch as purely on or off. The one piece converter clutch signal valve is stroked by 2nd clutch fluid pressure in 2nd,

3rd, and 4th gears to direct TCC signal fluid to between the converter clutch apply valve and the TCC solenoid in the pump. During converter release, the signal oil is exhausted through the normally open TCC solenoid. When the PCM (power control module) commands apply, the TCC solenoid is energized, and signal oil strokes the converter clutch apply valve, which applies the converter clutch.

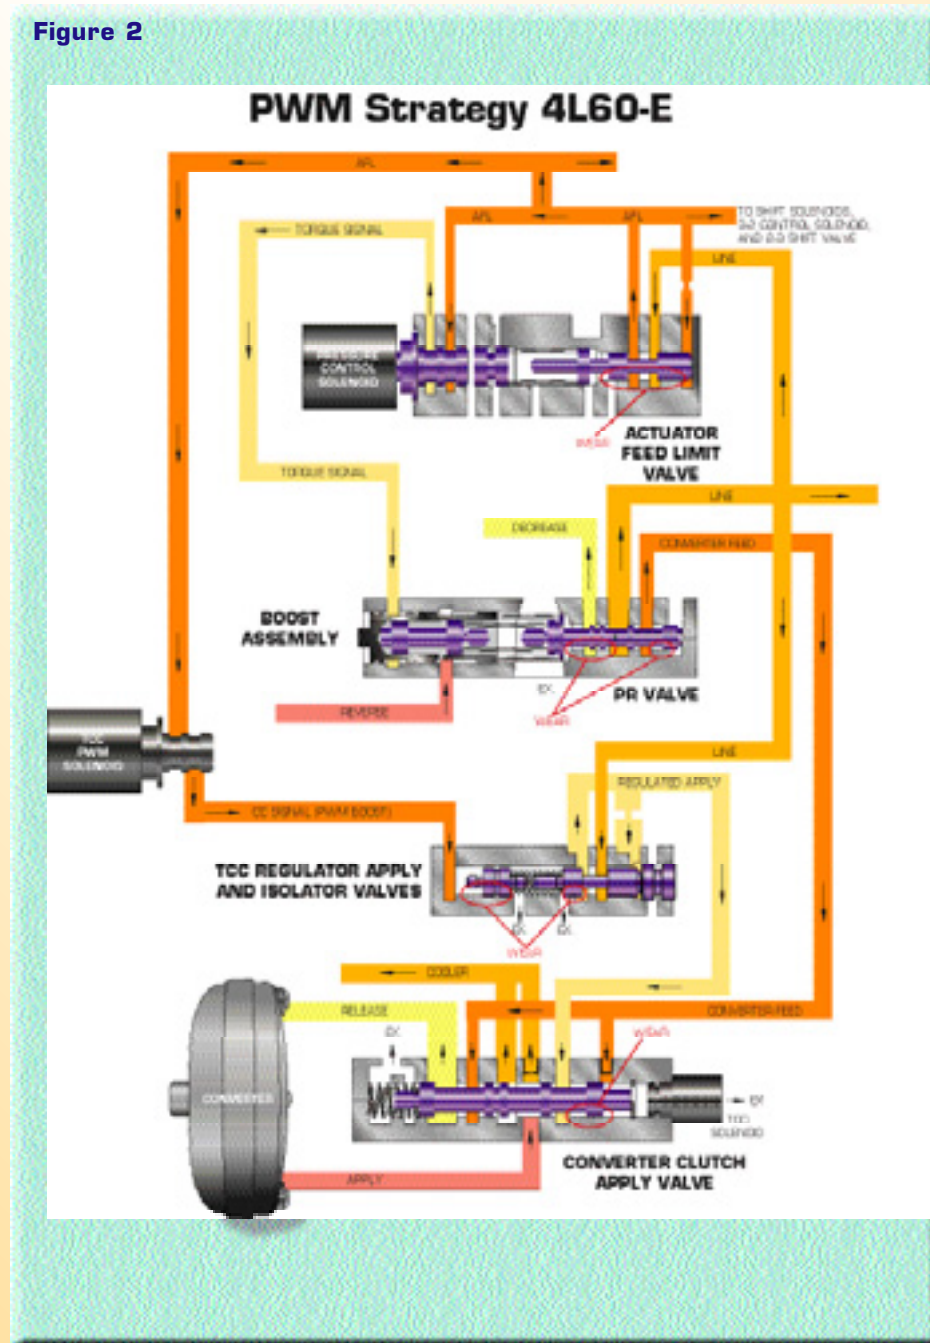
Figure 2

The PWM strategy (Figure 2) added a TCC PWM solenoid to control fluid acting on the TCC regulator apply and isolator valves, which replaced the one-piece

converter clutch signal valve. This was designed to provide smooth engagement of the torque converter by operating on a negative duty cycle percentage of “ON” time, and allowing the converter clutch to briefly slip or ease onto the cover. Line pressure, biased by CC signal oil, becomes regulated apply pressure at the TCC regulator valve, and is directed to the converter clutch apply valve. In the PWM circuit this apply pressure is *not* fed to the *end* of the apply valve, but to *between* the first two apply valve spools. Thus, when the valve strokes, this regulated apply oil is sent directly to the converter.

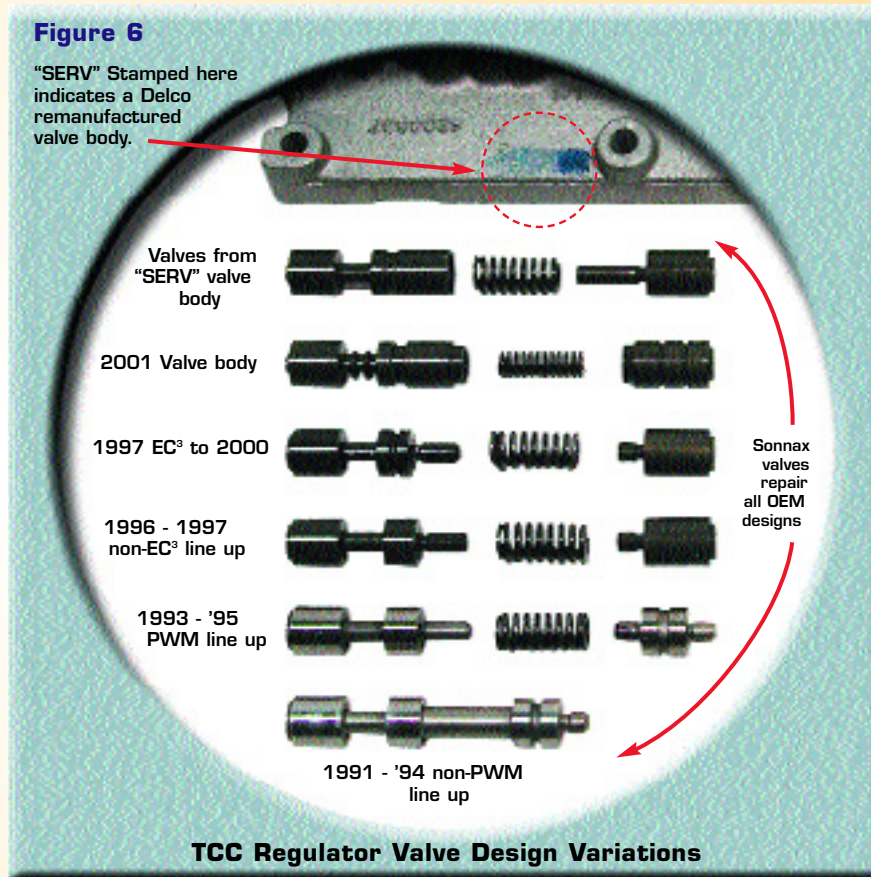
**Figure 6**

"SERV" Stamped here indicates a Delco remanufactured valve body.

**TCC Regulator Valve Design Variations**

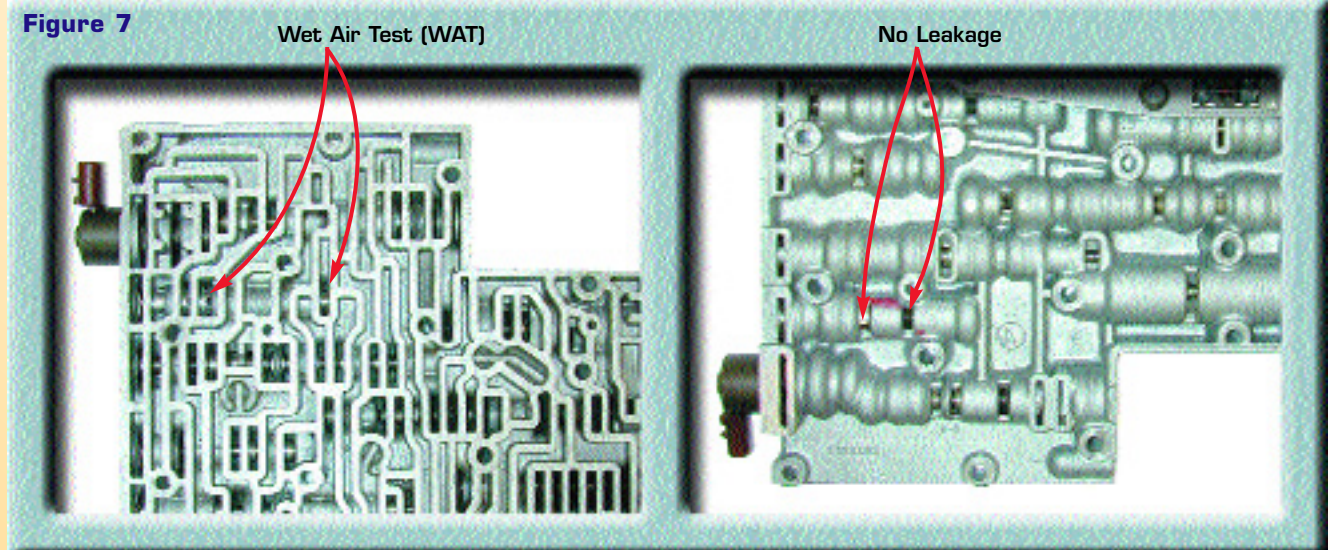
**Figure 7**

Wet air tests can be easily performed (*Figure 7*) to check for bore wear at the isolator and regulator valves. Sonnax offers two TCC regulator valve kits, 77754-03K and -04K, and an isolator sleeve, 77754-ISO, which will allow the repair of any of GMs valve line-ups, including the Delco remanufactured valve bodies. Details on these can be found on their individual product pages, 74 and 75. Essentially, the 77754-03K is designed with a slightly increased TCC apply rate, and should only be used on non-EC<sup>3</sup> units. The 77754-04K offers a stock TCC apply rate, and can be used on all three GM strategies. The 77754-ISO is a sleeve for the Sonnax isolator valve, and may be used in conjunction with the -03K and -04K kits for all strategies if severe isolator bore wear is present.

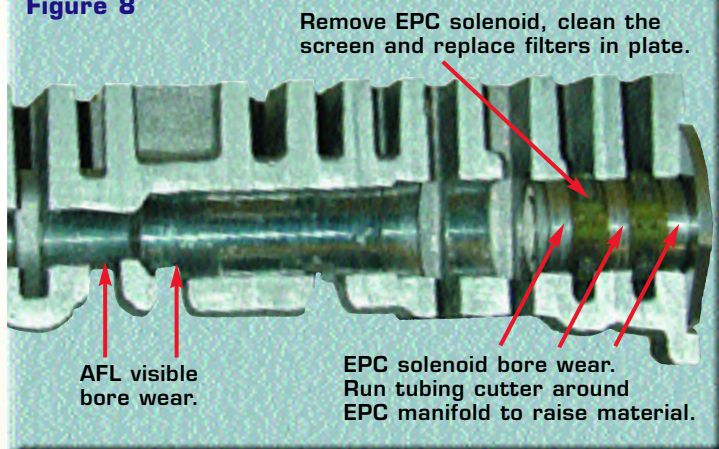
**Figure 8**

The AFL bore is difficult to wet air test. There are two options for detecting wear: remove the valve and look through the casting ports at the indicated areas for wear (*Figure 8*), or pry the valve slightly from both sides of the stem and look for a loose fit (*Figure 9*). Sonnax offers a redesigned AFL valve with a wear resistant sleeve, page 84, which can be used to refurbish this bore.

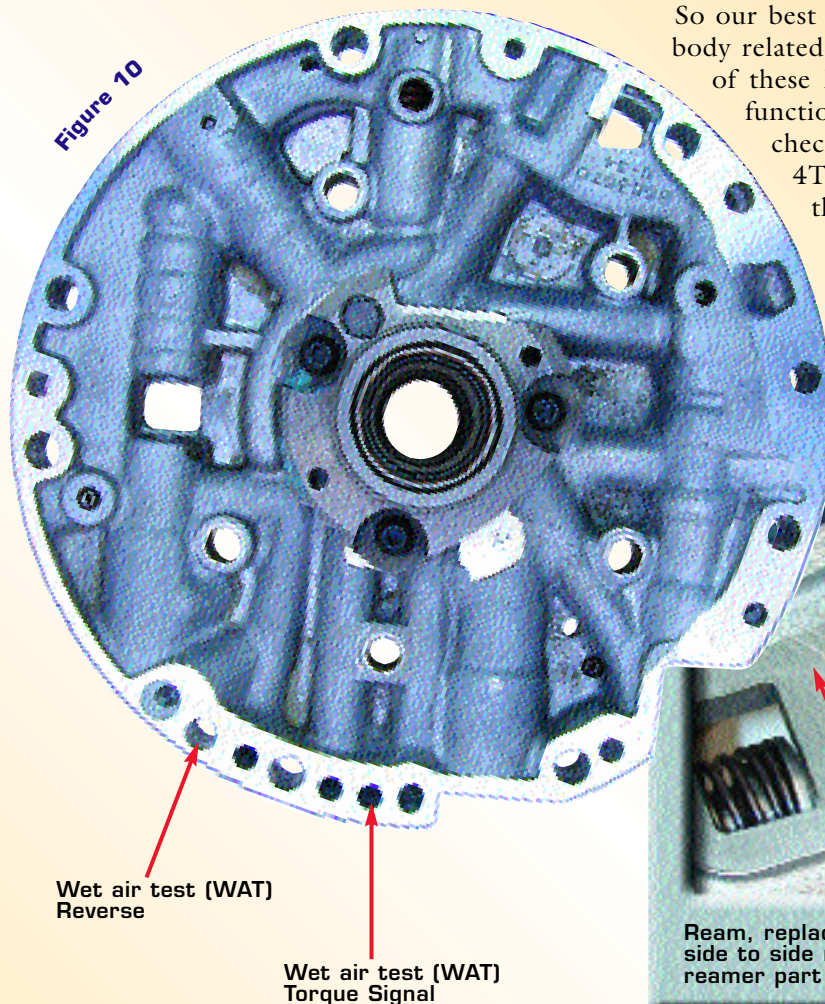
The boost valve assembly may be removed from the pump and easily wet air tested at the bench, or left in the assembled pump and wet air tested (*Figure 10*). Sonnax offers replacement assemblies for this application, as seen on page 85. The pressure regulator bore is difficult to wet air test, but can be checked for excessive side-to-side movement (*Figure 11*). Sonnax offers an oversized pressure regulator valve, on page 70, that allows the bore and hydraulic integrity to be refurbished.
