Clutch/Band/Line Accumulator Piston Kit

15741-14K

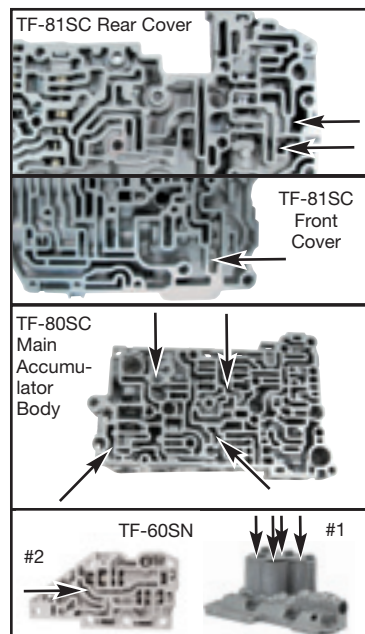
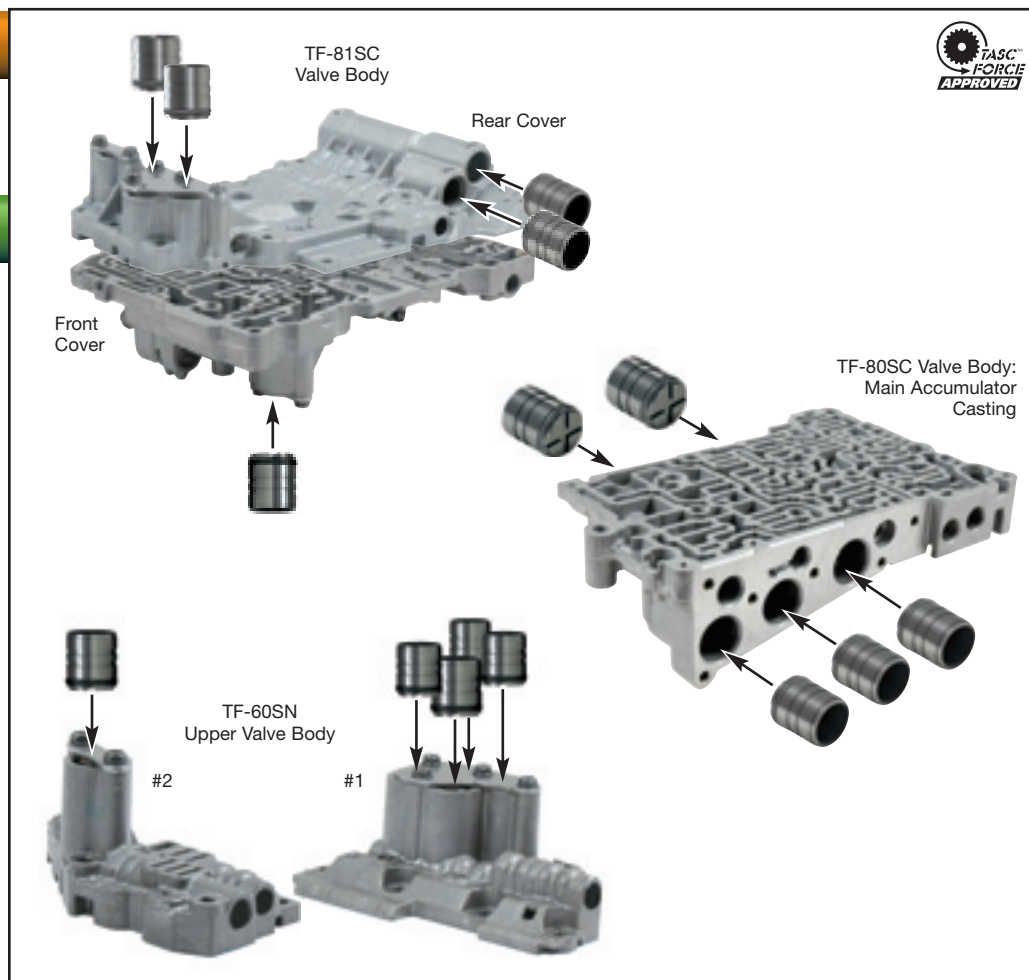
Wet Air Test Locations:

Wear at the cast aluminum accumulator bores by the steel pistons allows apply oil to exhaust.

Visual inspection of the bore often shows shiny patches of wear. If wear is visible, perform a Wet Air or Vacuum Test in the necessary locations as shown. Vacuum test must hold a minimum of 18".

The drop-in replacement anodized aluminum Sonnax accumulator pistons incorporate an o-ring for positive sealing and annular grooves for better centering and wear prevention.
