Checkball Springs

119940-20

Sonnax Part Summary

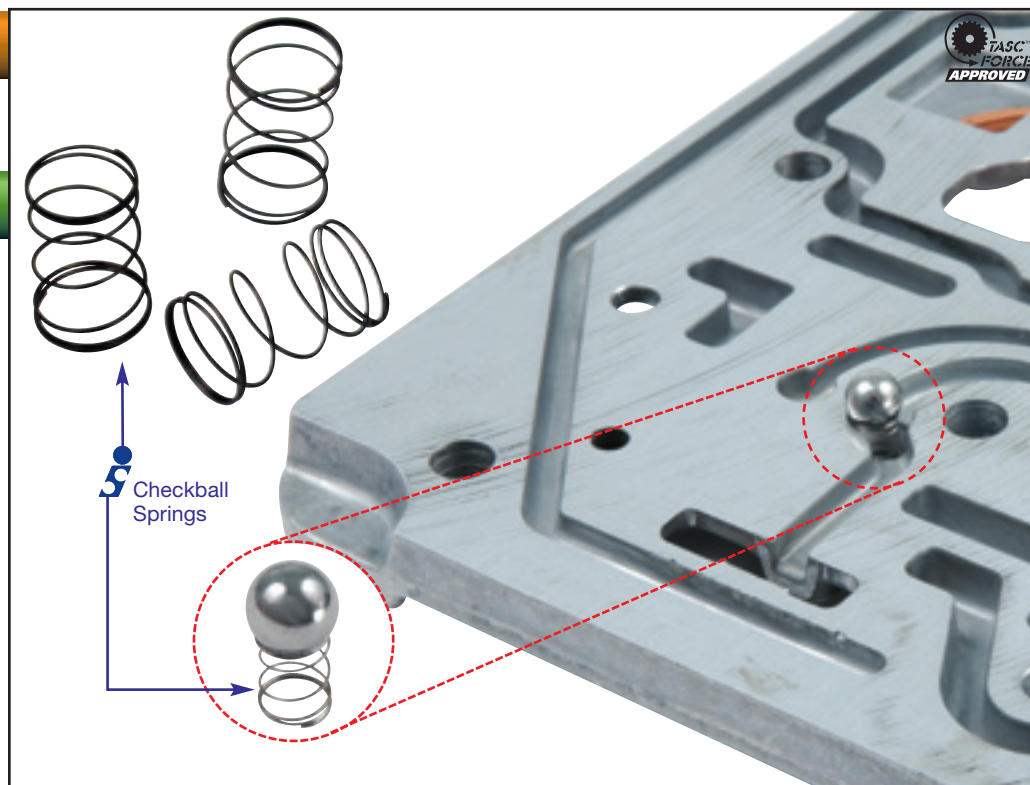
2-3, 3-2 shift complaints

- Soft shifts • Insufficient line rise • Erratic buzz or uncontrollable pressure in reverse

Breakage or collapse of the channel plate/lower cover checkball spring.

The channel plate/lower cover checkball and spring in the various 01M series valve bodies aid in controlling solenoid regulator pressure. When the spring breaks or collapses, proper fluid control is not maintained, resulting in 2-3 and 3-2 shift complaints. The Sonnax checkball spring 119940-20 restores proper fluid control.

Replace the spring with this direct replacement version.

Note: Some of the Phase 0 and 1 valve bodies (096, 097, 098) also contain this checkball spring. This replacement spring may be used in those applications after the location and spring specifications are verified. The OEM spring should measure .008" wire diameter, .178"/.194" outside diameter, and approximately .280" long in order to use this replacement spring.
