1-2 Accumulator Piston Spring Kit

96706-02K

Sonnax Part Summary

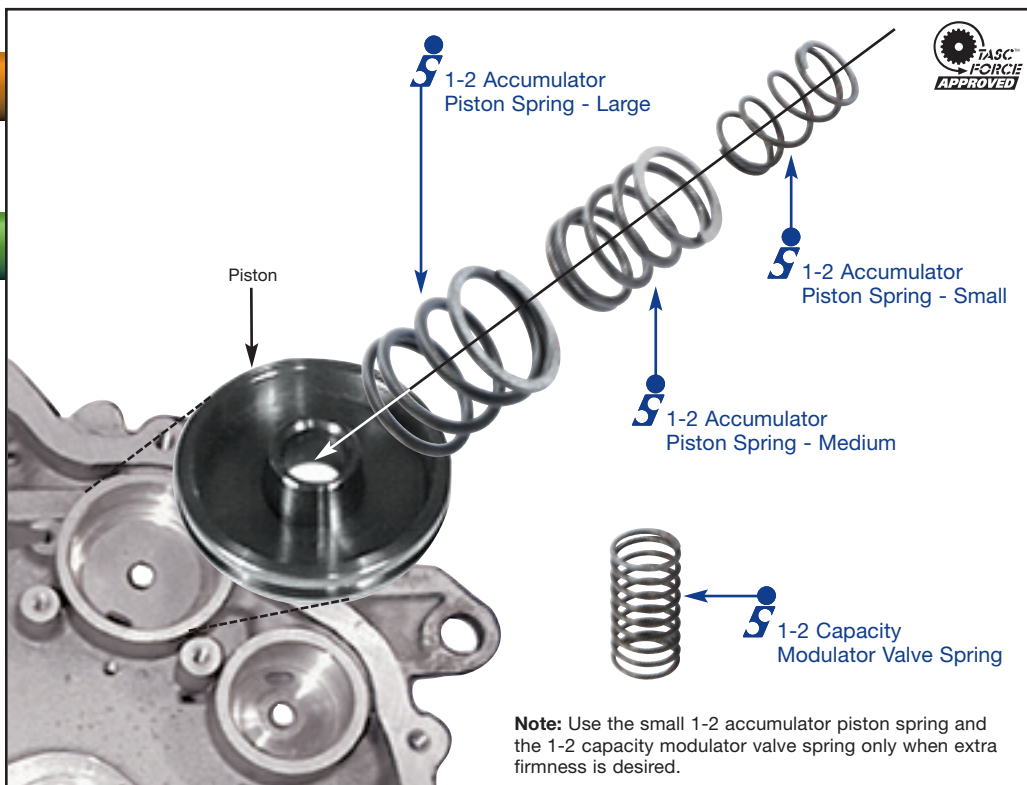
1-2 shift is too soft or long

- Persistent 1-2 slide shift with end bump
- Calibrated 1-2 accumulator shift springs difficult to find

Fatigued or poorly calibrated springs result in ineffective accumulator action.

The Sonnax springs can improve clutch feed or reduce accumulator piston rate, depending on selection.

1-2 Accumulator Spring	Large
1-2 Accumulator Spring	Medium
1-2 Accumulator Spring	Small
1-2 Capacity Modulator Valve Spring
