## Boost Valve & Sleeve Kits

The steel OEM valve in A340, A340E/F transmissions reciprocates within the cast aluminum sleeve, wearing the sleeve. After this wear becomes severe, it does not operate properly, causing soft upshifts and delayed engagement. Sonnax offers two replacement boost valve and sleeve kits 97855-23K and 97855-30K to restore proper operation.

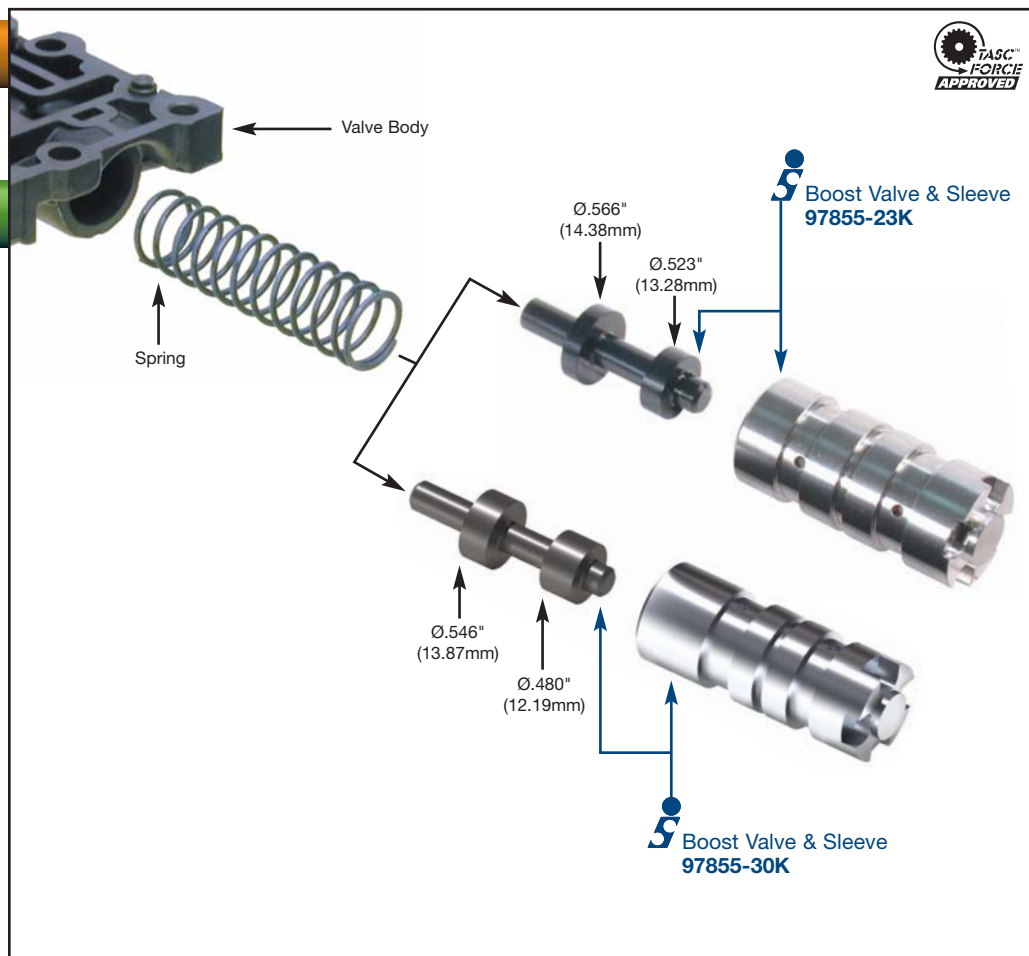
## Soft upshifts, delayed reverse

- Higher than normal pressures in reverse • Repeated clutch failure

Severe wear of the boost sleeve allows TV and boost oil leakage.

The replacement boost valve and sleeve assembly restores hydraulic integrity and prevents cross leaks.
