When in Doubt,

retrofit

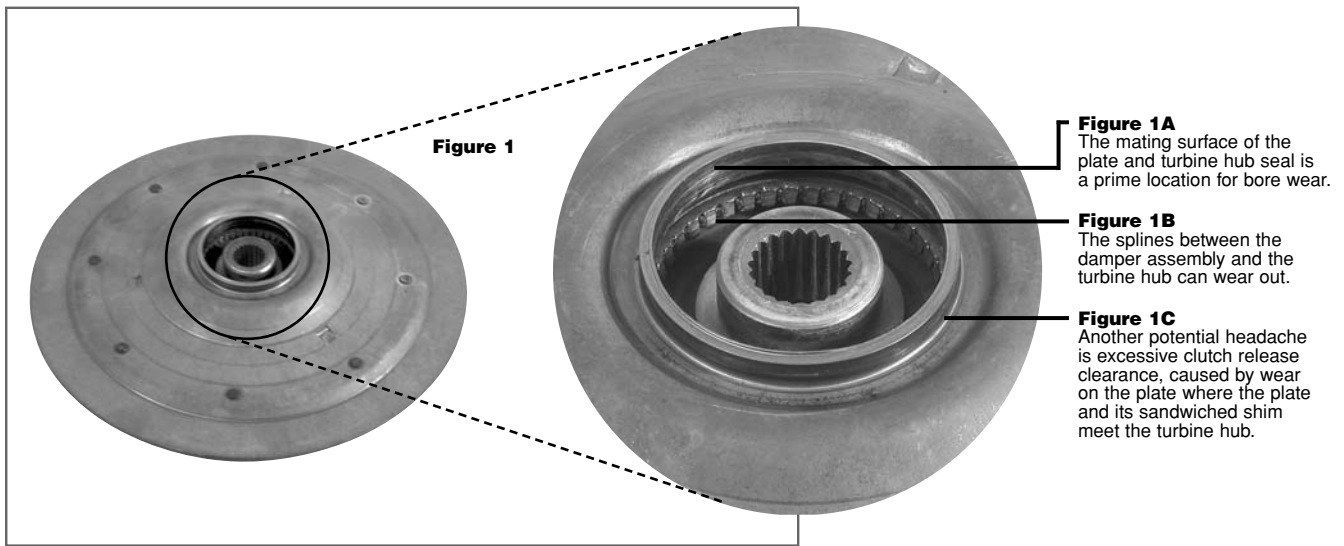
Then, once you've addressed the spline insert issue, you still may have to contend with bore wear. The mating surface of the plate and the turbine hub seal (see Figure 1A) is a prime location for bore wear. OK, you can deal with that, right? But once you've solved this problem, there are more potential headaches to face

You may be looking at worn-out splines between the damper assembly and the turbine hub (see Figure 1B). Or, you may find excessive clutch release clearance caused by wear on the plate where the plate and its sandwiched shim meet the turbine hub (see Figure 1C).

There may be better solution: You can retrofit a FD-HT-25HS turbine hub into the turbine and use the FD-DA-7 damper assembly. Start by cutting the original turbine hub out of the turbine. Measure the diameter of the turbine hub where it fits into the turbine, before you set up the turbine in the lathe. Hold the turbine by the hub with the stator side facing the tool post.

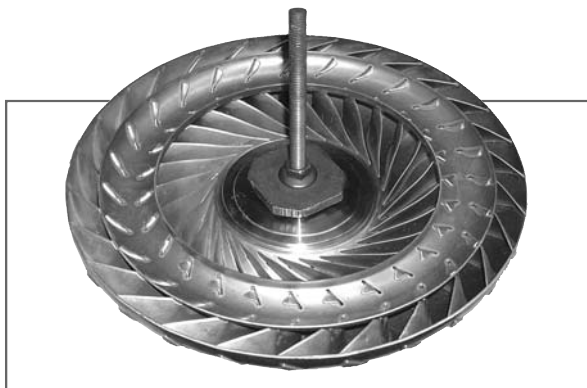
Figure 2
Hold the replacement hub in the turbine and weld into place.

Protect the surface to be welded and spray the remaining area of the turbine with anti-splatter spray. Protecting the area that will be welded from the anti-splatter spray will keep the weld from being contaminated. Hold the replacement hub into the turbine (Figure 2) and weld into place. Your finished product will look like the turbine in Figure 3.

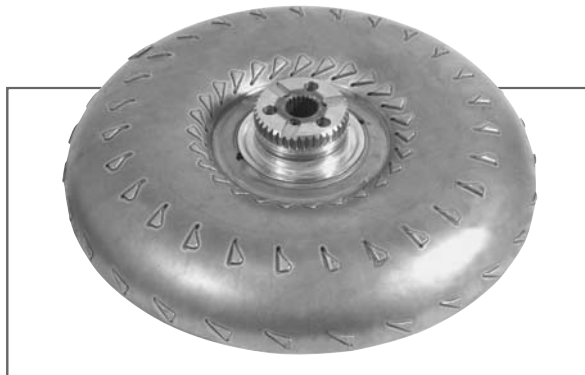
Figure 3
Your finished product should look like this.
