## Center Support/ Overdrive Shaft Sleeve Kit

### 56219-05K

### 56219-06K

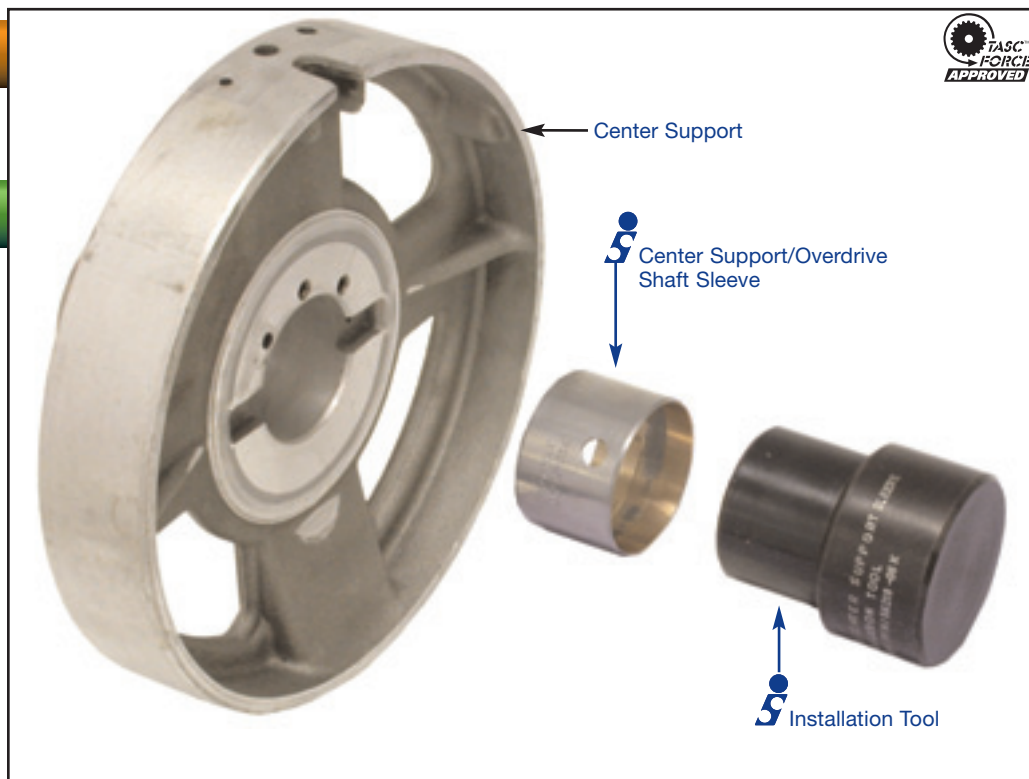
## Delayed forward engagement, forward clutch failure

- Overdrive clutch retainer springs blow out

The overdrive shaft is not supported by the center support.

The A4LD is designed so the overdrive shaft is supported at its tip by the output shaft. The support is not adequate enough to prevent vibration of the overdrive shaft. Often, the lack of support for the overdrive shaft allows the overdrive sprag to contact the overrun clutch retainer, causing the retainer springs to blow out. Even if contact does not occur, vibration of the overdrive shaft is transferred to the forward clutch drum and causes increased wear between the forward clutch sealing rings and the center support. Eventually the wear leads to leakage of forward clutch oil. To correct the situation Sonnax has introduced a sleeve **56219-05K**.

This sleeve provides positive support for the overdrive shaft.

- Sleeve supports the overdrive shaft directly in the center support.
- Support sleeve greatly reduces movement of the overdrive shaft, which reduces wear at the center support.
- The **56219-05K** sleeve fits into the center support without any machining required to shaft or support.
- Sonnax also offers an installation tool for pressing the sleeve into the center support. The installation tool kit **56219-06K** includes a support sleeve.

**Note:** Following installation of the Sonnax sleeve, the tip of the overdrive shaft (where it fits into the output shaft) should be ground off. This eliminates the potential for binding that can occur by supporting the overdrive shaft in two locations.
