Throttle Valve Sleeve Kits

Sonnax Part Summary

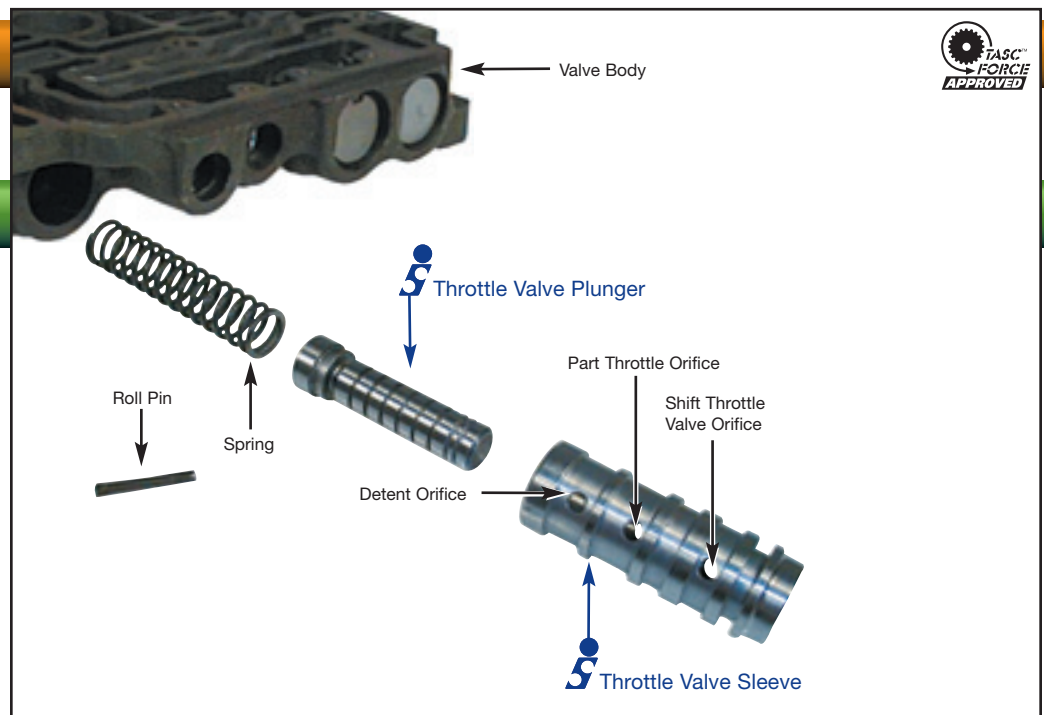
Soft 1-2 shift, poor detent and upshift control

Wear at the internal sleeve diameter allows TV and detent oil to exhaust.

Poor line rise, no detent downshifts, and soft 1-2 shifts are common complaints in vehicles with a THM 200 transmission. The steel throttle valve plunger continuously reciprocates within the steel throttle valve plunger sleeve, wearing the sleeve. This wear allows shift TV oil to leak past the plunger and exhaust, resulting in poor line rise. Also, detent feed oil leaks past the plunger and results in poor shift timing and/or soft shifts. This excessive leakage can be eliminated by installing one of three Sonnax replacement throttle valve plunger and sleeve kits: **65754-01K**, **65754-02K** or **65754-03K**.

These valve and sleeve kits eliminate both shift TV oil leaks and detent feed oil leaks.

- Both the sleeves and plunger valves have been tightly toleranced to restore the hydraulic integrity of the circuit.
- Annular grooves have been added to the plunger valves for cleaning and to minimize side loading that creates friction leading to sticky and erratic operation.
