Pump Gears

36438A-01K Direct Replacement

36438AX-01K Oversized

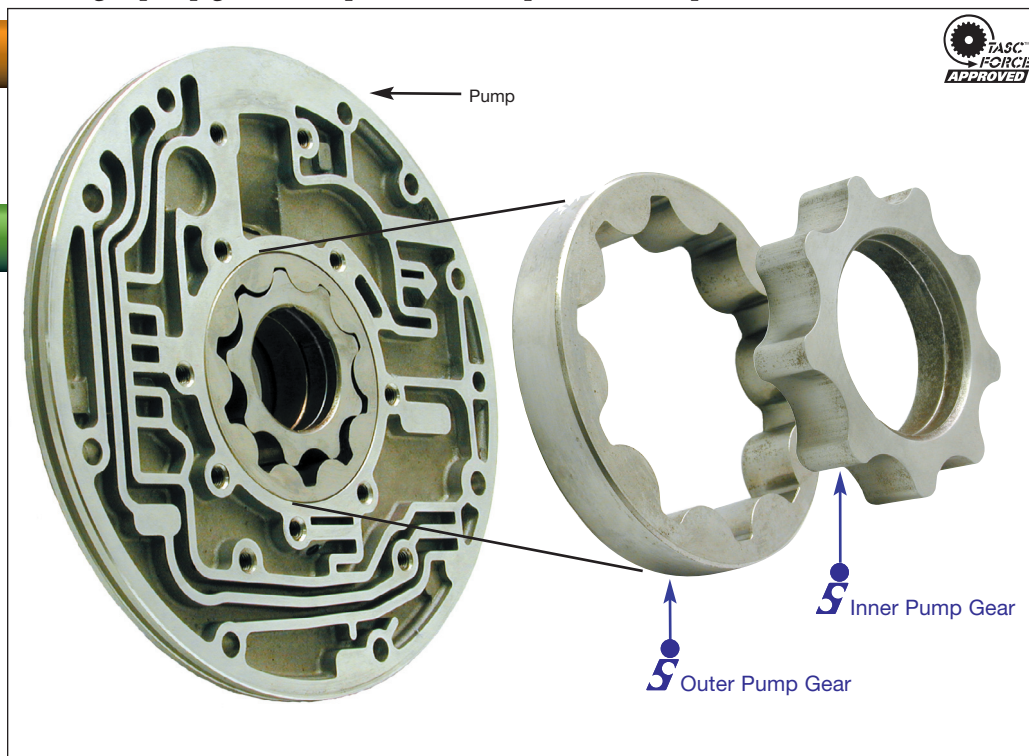
Low line pressure, excessive pump noise, code 62

- Damaged pump gears or torque converter impeller hub • Repeated converter failure

Wear on the pump gears and with the mating impeller hub reduces pump capacity and increases pump noise.

These direct replacement and oversized gears are specially designed to improve the fit and durability of the pump-to-torque-converter interface.

- No machining is required for direct replacement **36438A-01K**.
- Machining is required for oversized **36438AX-01K**. This kit is for F5 or later pumps only and cannot be used to update earlier pumps.
